# North Shore Hydrological Services

## MEMO

Re: 7/3/22 site visit to Wai`ale`ale and Waikoko Stream diversions

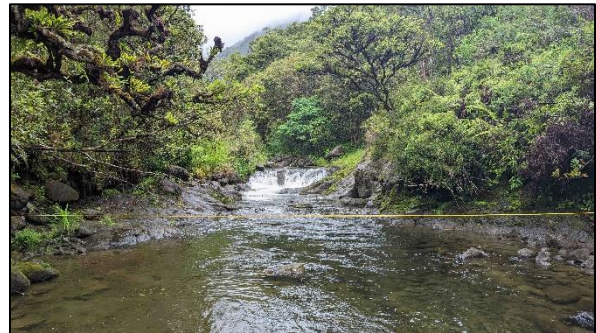
Because the Ili`ili`ula-North Wailua Ditch has not been diverting water down-ditch to the Upper Waiahi Hydropower Plant for the last several years because of a break in the ditchline, the CWRM gaging station 2-191 'NF Wailua blw Bluehole Intake' has recently been producing a record of the total (undiverted) streamflow available in the North Fork Wailua River (aka Wai`ale`ale Stream). This dataset may prove to be extremely valuable in the establishment of a new Interim Instream Flow Standard (IIFS) for this stream. For this reason, I wanted to make a flow measurement at the CWRM gage station site as a spot check on its accuracy. The measurement was made using a Sontek FlowTracker2 acoustic velocity meter at a cross section approximately 20 feet upstream of the gage station's water level sensor (see inset photo). The staff gage readings during the measurement were 2.30 – 2.34 feet. The measurement was performed between 10:00 and 10:40am on 7/3/22, and the resulting flow value was 25.7 cfs. The CWRM gage station website reported a streamflow value of 25.3 cfs for this time period, which is in remarkable agreement with the field measurement I made. Based on this, I conclude that the gage station is well-

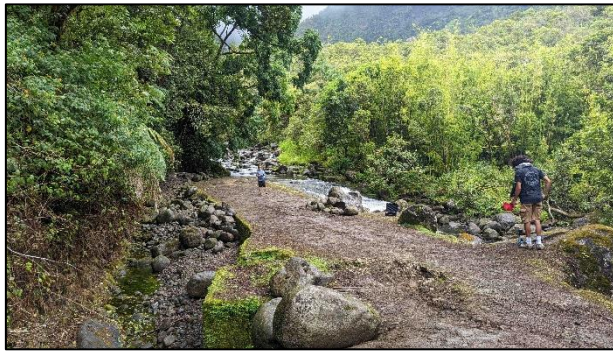
The Ili'ili'ula-North Wailua Ditch was filled in with sediment near the intake at Wai'ale'ale Stream during the site visit (see inset photo), so no measurable flow was being diverted from the stream into the ditch. The headgate in the ditch was fully boarded just down-ditch of the return flow "throw-out" which means that any water diverted from the stream into the ditch at higher flow should be blocked by the headgate and re-routed back to the stream channel through the

throw-out. Because no water was passing the headgate at this diversion, no water was overtopping the flow measurement weir just down-ditch from the headgate. On this day, no water was being diverted from Wai'ale'ale Stream into the Ili'ili'ula-North Wailua Ditch.

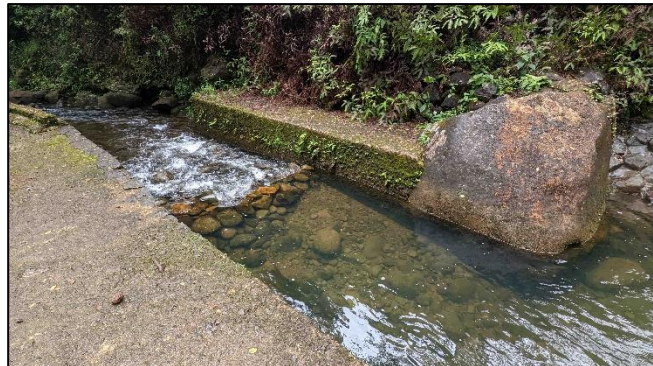
only a trickle of flow in the Waikoko Stream channel between the diversion dam and the point roughly 300 feet downstream at the confluence with the throw-out channel (see inset photo, at left). Just like at the Wai'ale'ale Stream diversion site, the headgate just down-ditch of the throw-out was well-boarded to prevent flow from passing further down the ditch to the south. Instead, all of the flow from Waikoko Stream captured by the ditch was being returned

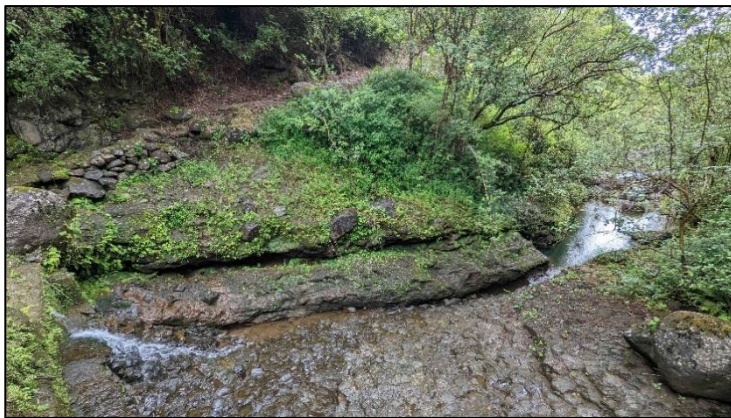
At the Waikoko Stream point of diversion, rocks had been stacked in an apparent attempt to limit the amount of water captured into the ditch, but this was largely ineffective (see inset photo, at right). I estimate that over 97% of the combined flow from the two branches of Waikoko Stream was being captured by the ditch intake, with less than 3% spilling past the diversion dam via a small pipe through the dam and cracks in the dam structure. This resulted in

to the stream through the throw-out on this day. Although some rocks had been stacked in the ditch intake to limit water capture by the ditch, most of the stream water was still being taken into the ditch intake. It seems a headgate could be installed without too much cost or effort at the intake section that would allow for the ability to “turn off” this diversion. Flashboards could be used in steel channels mounted to the ditch’s concrete sidewalls, and when fully closed, this control would allow the full streamflow of Waikoko Stream to pass over the dam face, rather than being routed through the ditch to the throw-out channel. This would result in a much more natural flow pattern and improve conditions for passage of native aquatic species in this stream reach.

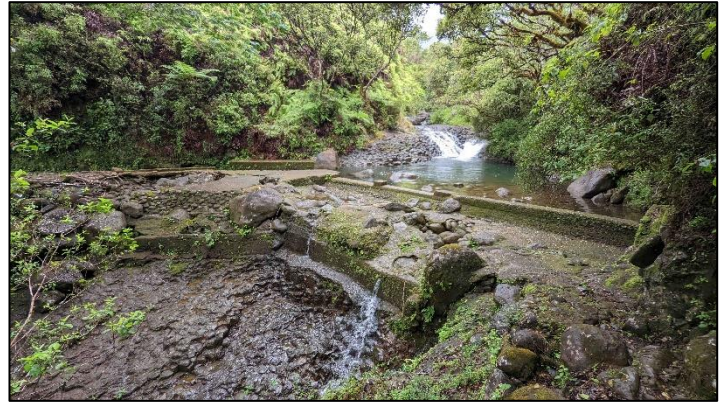
No measurements of flow in Waikoko Stream or the ditch were made. At the first tunnel approximately 100 feet down-ditch of the Waikoko headgate, there is a short weir in the ditch channel with a stilling well made of a vertical steel pipe on the ditch bank. This set-up is clearly intended as a water level / flow measurement station, but it is unclear if this station is operated by CWRM or the water diverter, or if it is functional at this time.

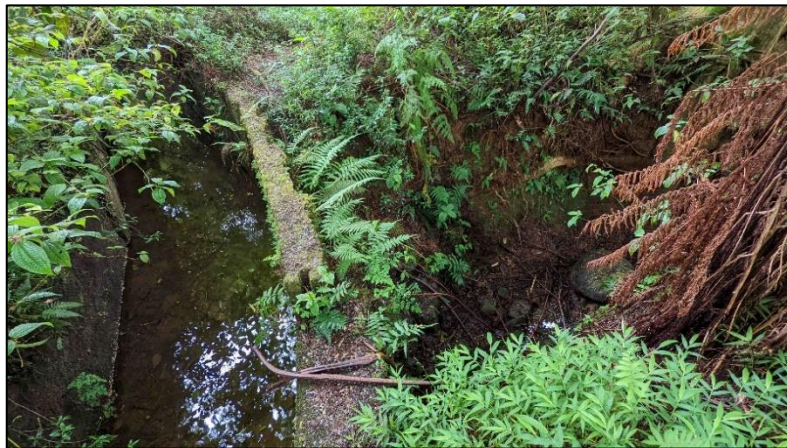
At one site along the ditch, I observed a spillway at a location where there was no natural stream channel upslope of the ditch, but there was a deep gully eroded immediately downslope of the ditch (see inset photo at left). I estimate this gully to be 10 feet deep, and it was clearly formed by water flowing through the spillway notch in the concrete ditch wall. The notch has slots for a wooden “pani board” or flashboard, but without the board in

place, this location serves as an overflow spillway during high rainfall events. It is not known how much of the gully erosion observed at this site is due to recent storm events, but judging by the vegetation on the gully walls, the erosion in this area appears to be active.

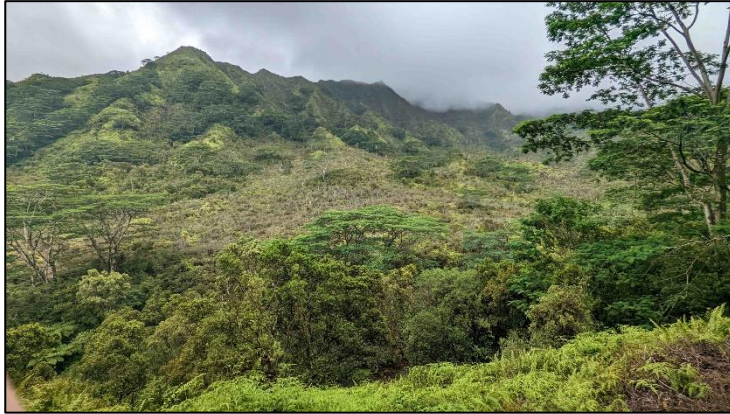
and small Albizia trees growing in the area, with many having branches hanging above open ditch sections (see inset photo at left, showing the area around the Waikoko diversion). This suggests to me that even if repairs were eventually made to the broken siphon, there would be substantial and perpetual maintenance and repairs needed in this area to keep the ditch functional, as debris loading from the Albizia overgrowth is problematic now and can be expected to become much worse in

the future due to the prodigious growth rate of this tree species in this environment. On the day of this site visit, I observed several open ditch segments where piles of organic debris from falling Albizia branches was clogging the ditch.
