**Hawaii Department of Health**  
**Clean Water Branch**  
**Complaint Inspection Report**

**Property Name:** Coco Palms Resort

**Inspection Date:** November 27, 2023

**Inspection Report Number:** KA0499

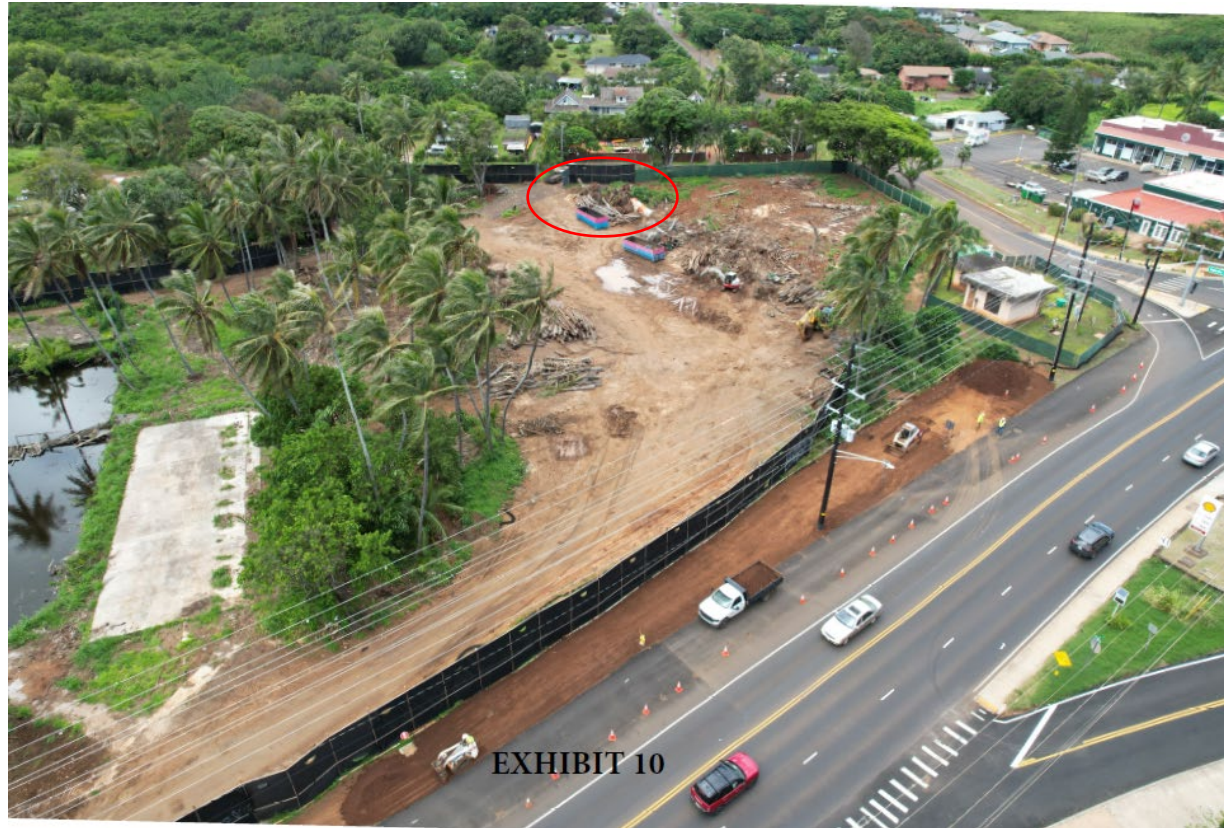
- e. *Potential Violation:* I observed several coconut root balls and bare soil located in the northern end of Parcel 7 where previous coconut tree clearing had occurred (Photographs 19-20). In the response to the NAV-RFI, Mr. Trask provided the definition of “grubbing” as it is defined in HAR§13-5-2 because RP21 believed it was instructive: “ “Grubbing” means the removal of vegetation by scraping, dislodging, or uprooting vegetation that breaks the topsoil.” The presence of several uprooted coconut trees and disturbed soil shows that grubbing, according to the definition provided by Mr. Trask, had occurred on Parcel 7. Image 5 reveals coconut root balls and trunks piled at the Site.

**Image 5:** Copy of “Exhibit 10” provided in RP21 Coco Palms’ response to the NAV-RFI. This image depicts an aerial view of the cleared area and construction debris at the Site. Note that the actual area cleared of vegetation is greater than the area depicted in the Image 4 showing the trees intended for removal. Also note the piles of root balls (red circle), stockpiles of construction debris, exposed soils, and heavy equipment present at the site.

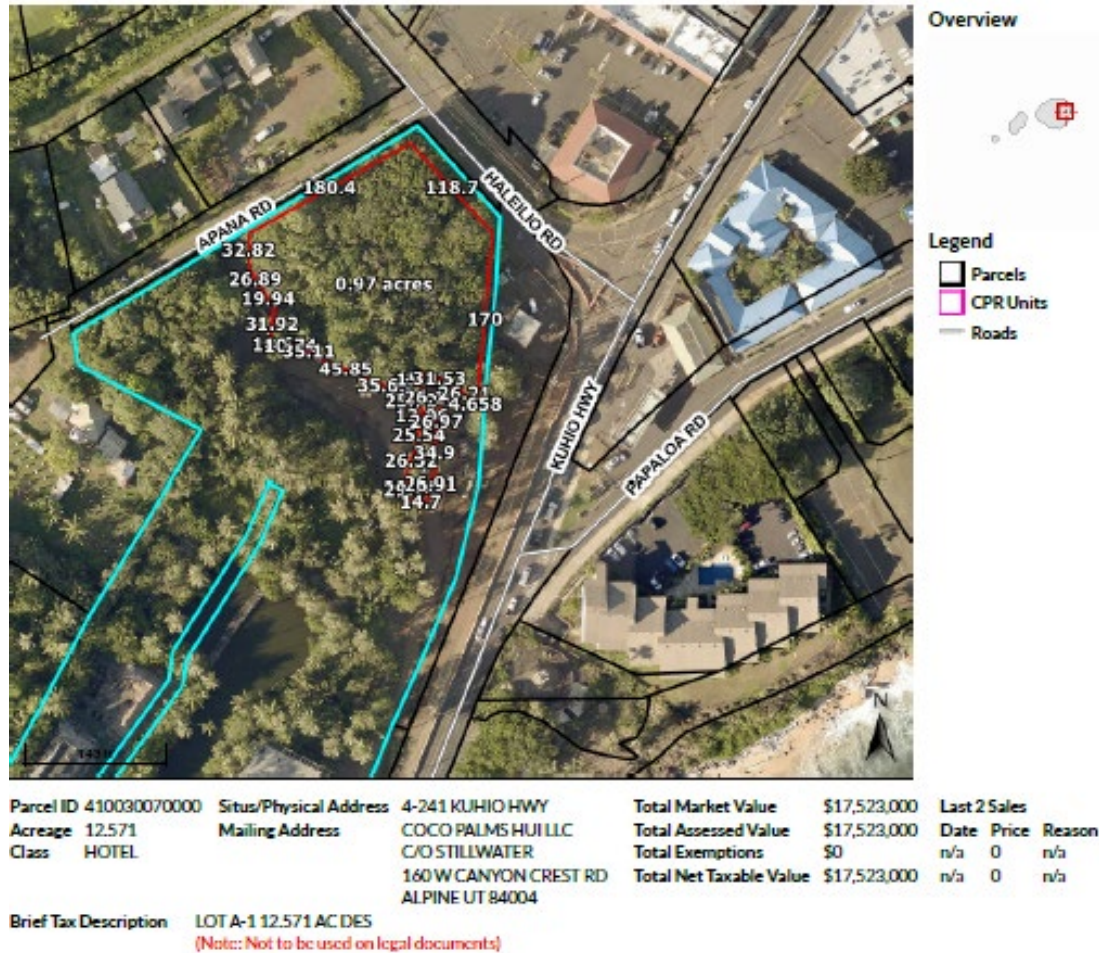
**Image 6:** Copy of “Exhibit 23” provided in RP21 Coco Palms’ response to the NAV-RFI. The calculated area of tree removal is identified at 0.97 acres and does not include the additional construction support areas identified in this inspection report.

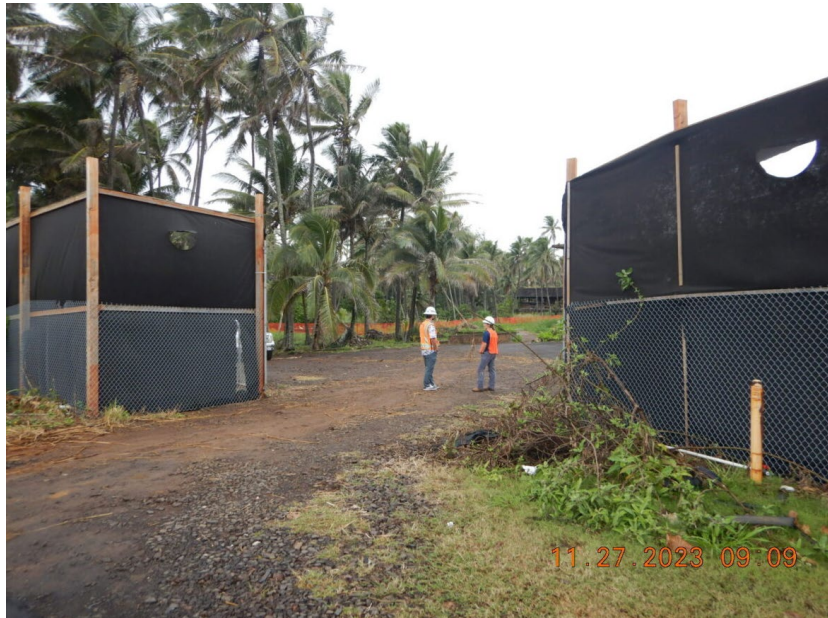
- a. *Potential Violation:* At the time of inspection, the Site contained three construction entrances. Two of the entrances were located off Kuamoo Road, and one entrance was located at Apana Road (Photographs 1, 11, 12). The three construction entrances are considered part of the construction support activities and must be included in the area calculation for NPDES coverage for storm water runoff associated with construction activities.

**Photograph 1:** View of the front entrance of the Coco Palms Resort Construction Site. This entrance is located off Kuamoo Road. Photograph taken by Randee Tubal on November 27, 2023.

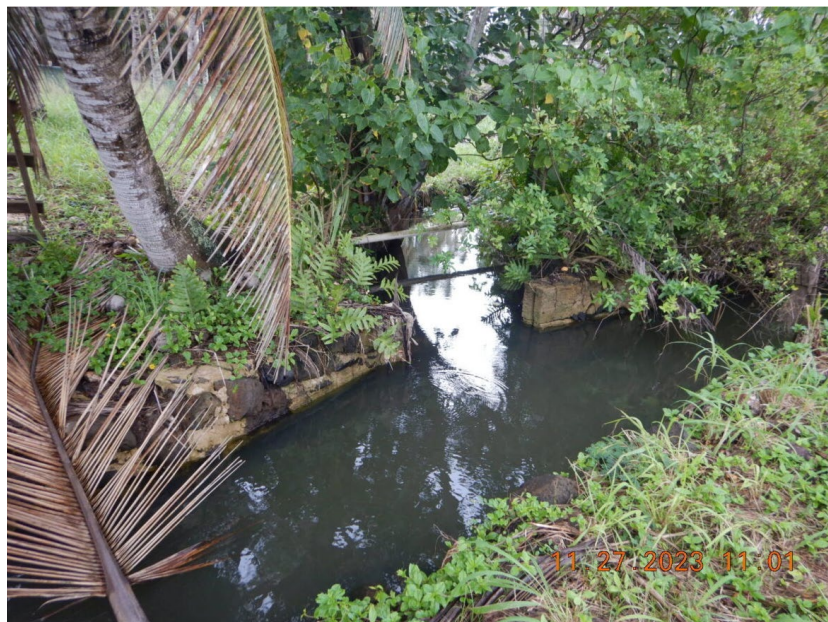
**Photograph 2:** View, facing west, of the convergence of the fishpond and ditch located on the southern end of the Site. Photograph taken by Randee Tubal on November 27, 2023.

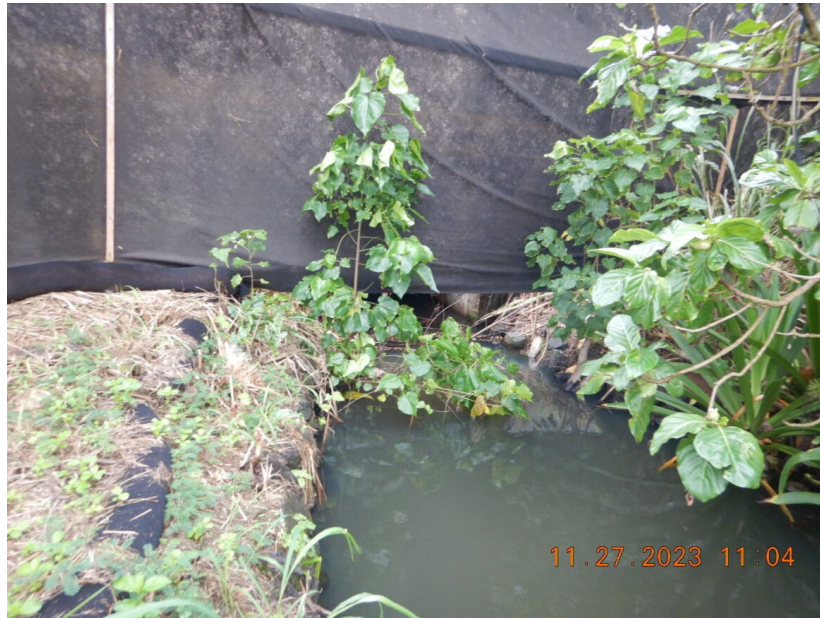
**Photograph 3:** View, facing south, of the point at which the drainage ditch exits the Site and connects further down to Wailua River. Photograph taken by Randee Tubal on November 27, 2023.

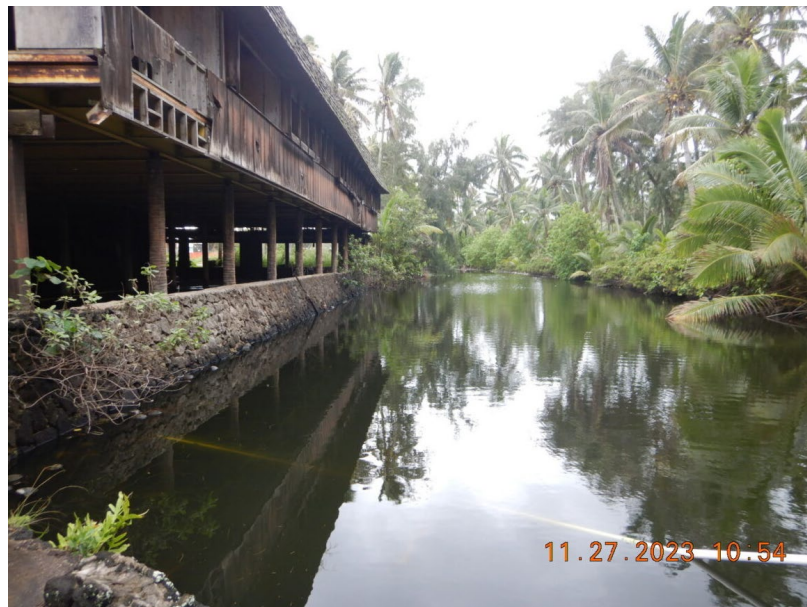
- a. *Observation:* The fishpond identified as the Weuweu-Kawai iki fishpond by the Historic Hawaii Foundation, located on Parcel 7 (Photograph 4), and the drainage

ditch located on Parcel 11 (Photographs 5-6) are both consistent with the definition of state waters as it is defined in Hawaii's Water Pollution regulations. Further, Mr. Rampton stated that the water levels in the fishpond and ditch system are influenced by the tide. As such, the DOH determines the fishpond and ditch to be State waters.

- g. *Observation:* Inspectors observed that buildings slated for construction are located immediately adjacent to the fishpond or state-owned ditch (Photographs 4-5).

**Photograph 4:** View, facing south, of the Weuweu kawai iki fishpond. Note that the building pictured on the left is one of the buildings that will be undergoing construction. Photograph taken by Randee Tubal on November 27, 2023.

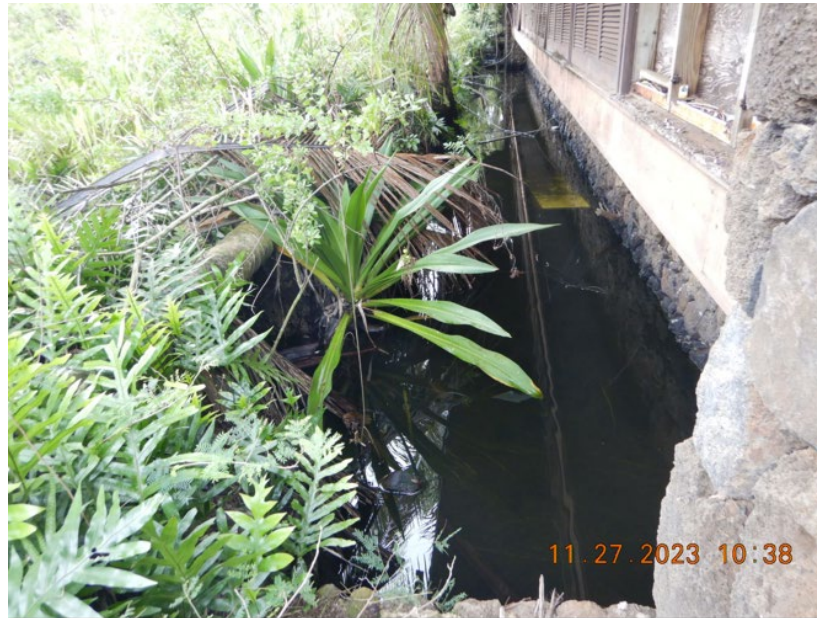
**Photograph 5:** View, facing south, of the State-owned Kawai iki ditch that bisects much of Parcel 7. Note that the ditch is located immediately adjacent to a building that will undergo construction activities. Photograph taken by Randee Tubal on November 27, 2023.

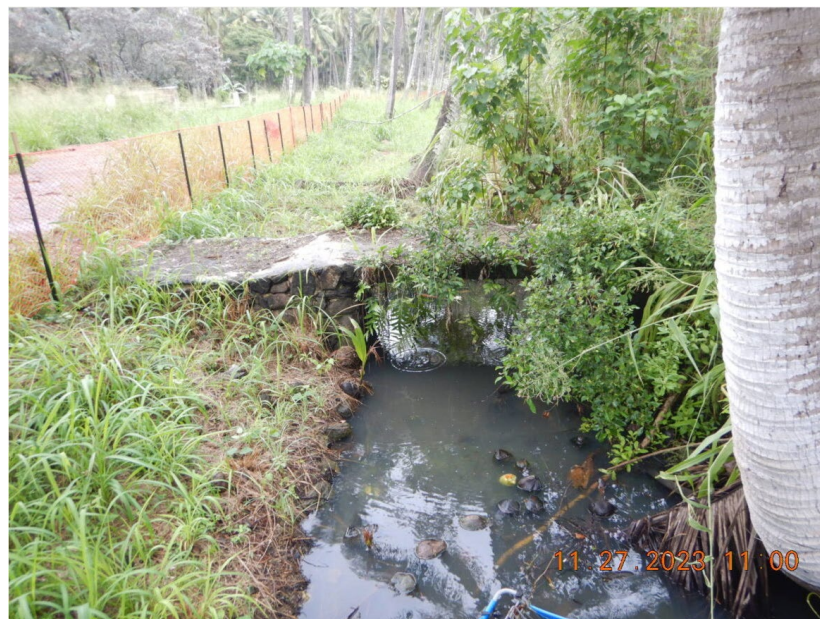
- a. *Observation:* No discharge of pollutants from the Site was observed during the inspection. Although vegetation and debris were present within the fishpond and ditch, its source is not attributed to construction activity occurring at the Site (Photograph 6).

**Photograph 6:** View, facing north, of the State-owned Kawai iki ditch. Note the vegetation and debris present in the ditch. Photograph taken by Randee Tubal on November 27, 2023.

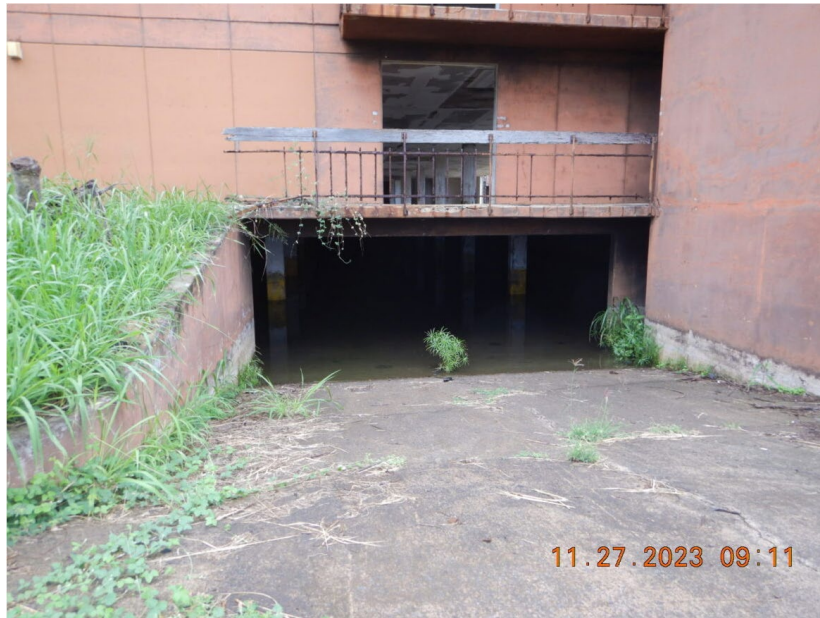
- b. *Observation:* Standing water was observed in the parking structures located under existing Buildings 1, 2, and 3 (refer to Image 3, Photographs 7-8). The source of the water is believed to be seepage of ground water. The standing water contained live fish, vegetation and sediment. The Site representatives were informed that standing water within the underground parking structures must be directed to either vegetated areas to allow for infiltration or to the sanitary sewer for treatment. Standing water is not an allowable discharge unless a permit or variance is issued by the director.

**Photograph 7:** View, facing north, of Building 1. Note the standing water located in the underground parking structure. Photograph taken by Randee Tubal on November 27, 2023.

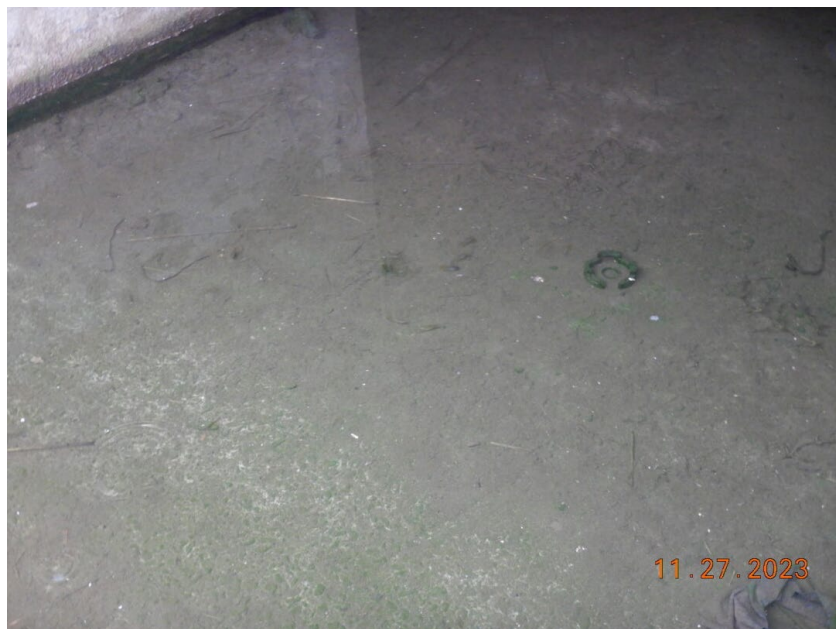
**Photograph 8:** Close up view of the standing water located in the underground parking structure beneath Building 1 (see Image 3). Photograph taken by Bobbie Teixeira on November 27, 2023.

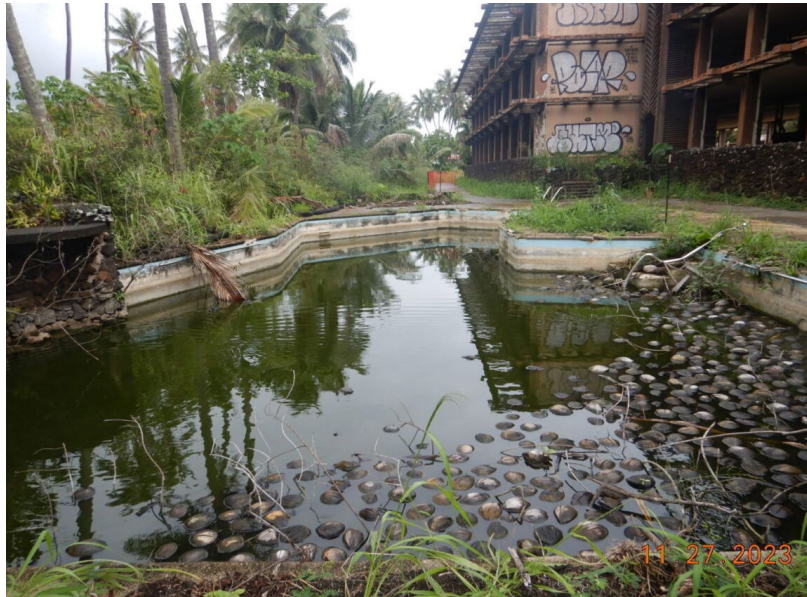
- c. *Observation:* Inspectors observed three (3) previously existing swimming pools on Site that was partially filled with stagnant green water and coconuts (Photographs 9-10). As with the standing water present in the underground parking structures, the water located in the pools is not an allowable discharge unless a permit or variance is issued by the director.

**Photograph 9:** View, facing north, of one of the three swimming pools on Site. Note that the pool is situated between the resort and the fishpond (refer to Image 3). Photograph taken by Bobbie Teixeira on November 27, 2023.

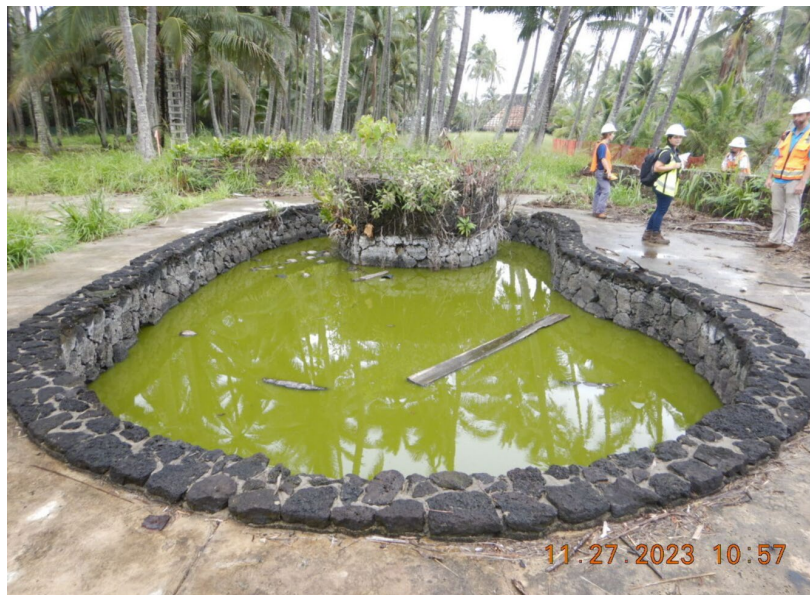
**Photograph 10:** View, facing north, of a reflection pool on Site. Note that the pool is situated west of the resort and the fishpond (refer to Image 3). Photograph taken by Randee Tubal on November 27, 2023.

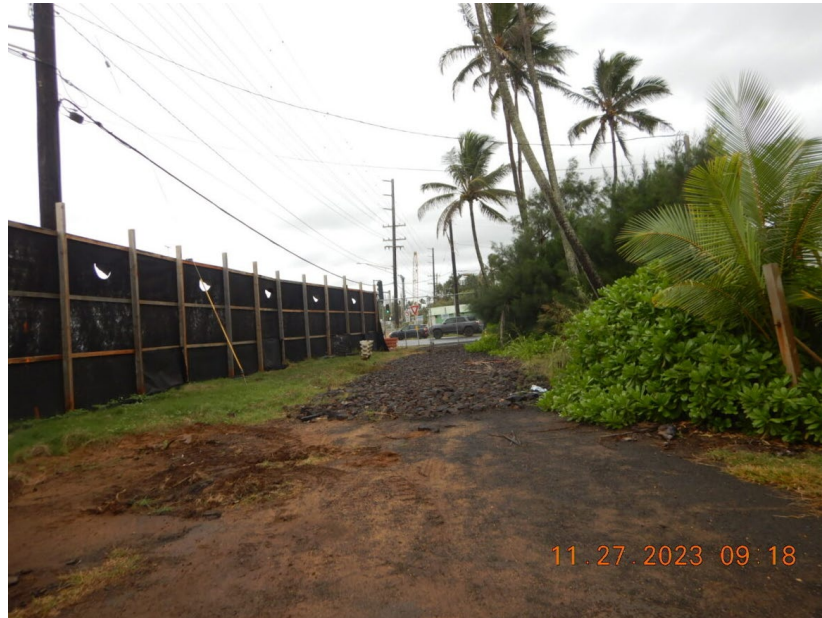
**Photograph 11:** View, facing south, of the second construction entrance located off Kuamoo Road. This entrance is approximately 20 m east of the entrance pictured in Photograph 1. Kuhio Highway is located on the other side of the dust screen. Photograph taken by Rande Tubal on November 27, 2023.

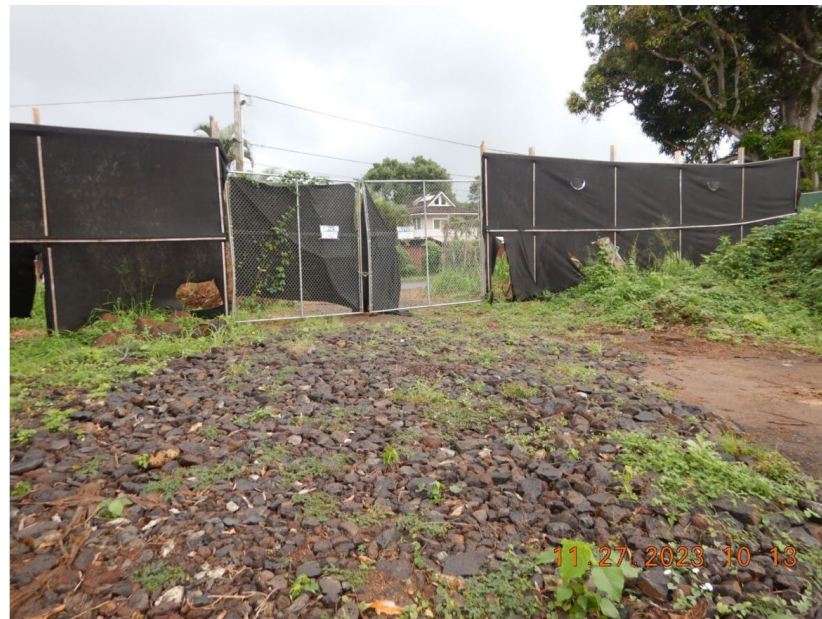
**Photograph 12:** View, facing northwest, of the third construction entrance located off Apana Road. Photograph taken by Rande Tubal on November 27, 2023.

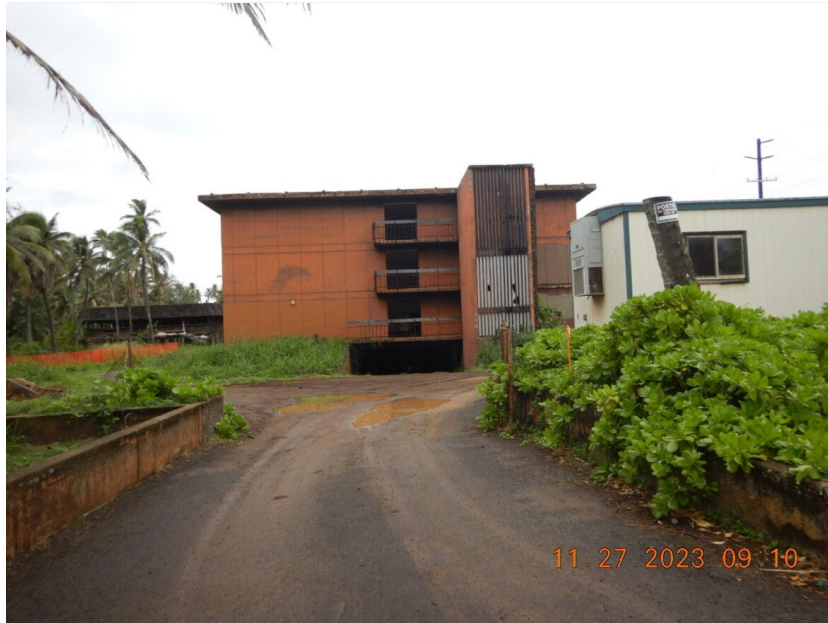
- b. *Potential Violation:* Construction support equipment was positioned in multiple areas located within Parcel 7, including office trailers, portable toilets, heavy equipment, roll off bins, and stockpiles of construction debris (Photographs 13-17). Staging areas must be included in the area calculation for NPDES coverage for storm water runoff associated with construction activities.

- d. *Potential Violation:* I observed an asphalt road, located between the existing buildings and the dust fence erected adjacent to Kuhio Highway, being used to transport heavy equipment (Photographs 13-14). Layers of dirt, gravel and sand were present on top of the asphalt road in many areas. Further, the road is used by vehicles and heavy equipment to traverse the Site. Therefore, the asphalt road is considered part of the construction support activities and must be

**Photograph 13:** Wide view, facing north, of Building 1. Note the construction trailer located to the right of the photograph. Photograph taken by Rande Tubal on November 27, 2023.

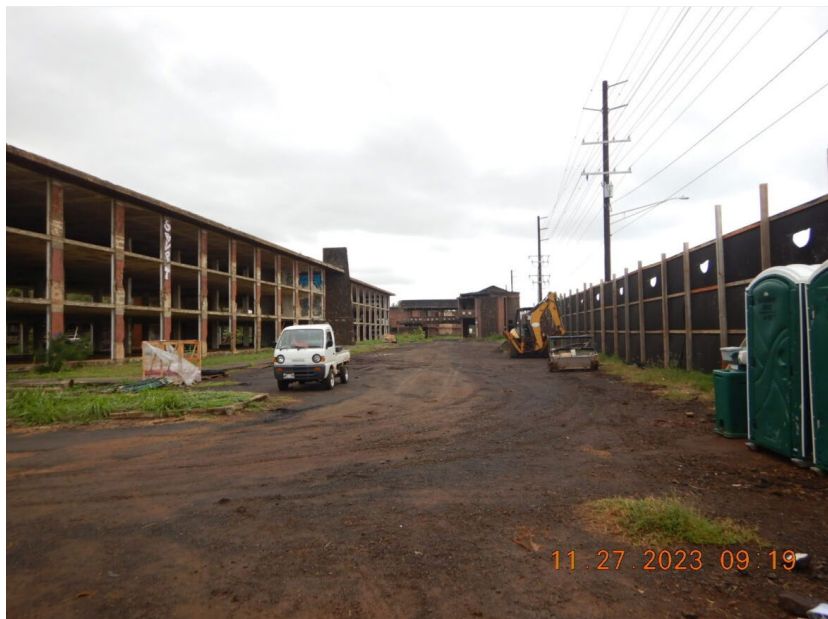
**Photograph 14:** View, facing north, of the road located between Building 1 and Kuhio Highway. Note the dust fence, heavy equipment, portable toilets, and handwashing station located in the enclosed area. Also, the road is covered with a layer of dirt, gravel and sand. The road is being used for vehicle and equipment to traverse the Site (see photograph 15). Photograph taken by Rande Tubal on November 27, 2023.

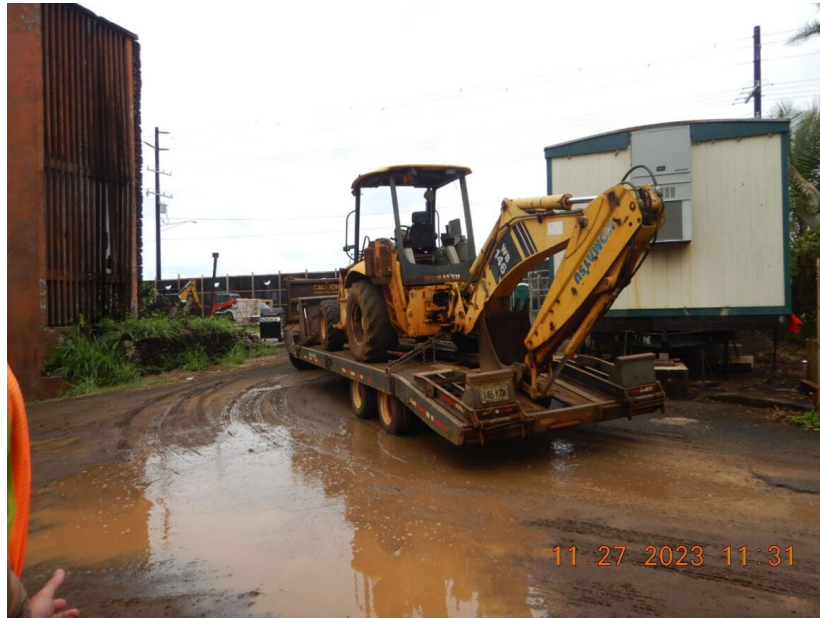
**Photograph 15:** View, facing northwest, of heavy equipment being trucked onto the Site. Photograph taken by Rande Tubal on November 27, 2023.

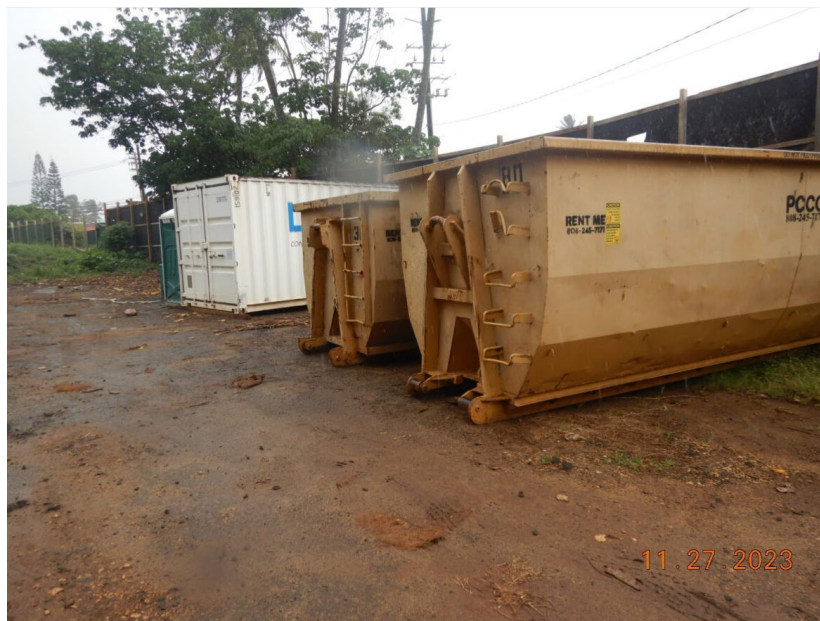
**Photograph 16:** View, facing northeast, of the asphalt road covered with dirt and sand, located between Building 1 and Kuhio Highway. Note, portable toilets, storage containers, and waste bins located in the enclosed area. Photograph taken by Bobbie Teixeira on November 27, 2023.

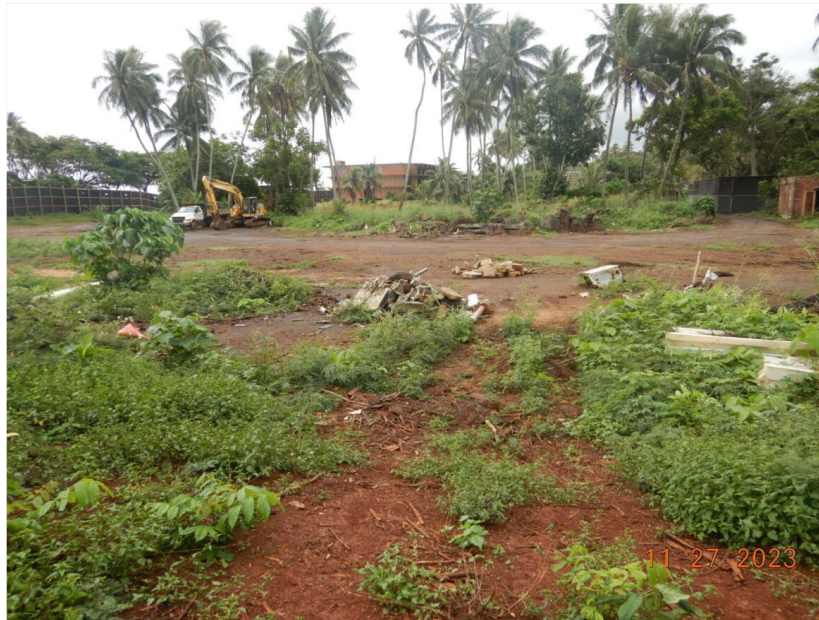
**Photograph 17:** Wide view, facing southwest, of northern portion of Parcel 7. Note the heavy equipment and piles of construction debris placed throughout the parcel. Also note that this portion of the parcel was cleared of numerous coconut trees (refer to Image 5, Photographs 19-20). Photograph taken by Bobbie Teixeira on November 27, 2023.

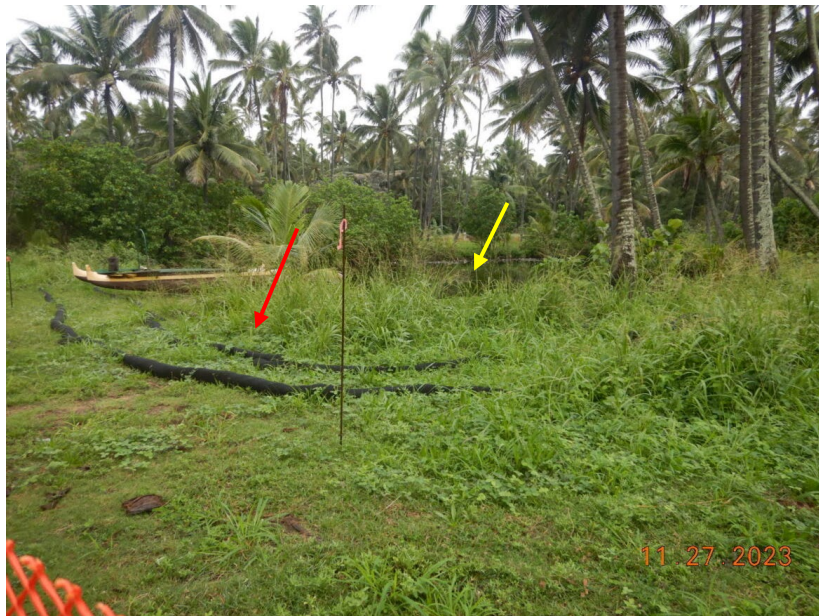
- c. *Potential Violation:* At the time of inspection, a dust fence was erected around the perimeter of Parcel 7, and filter socks were placed throughout the parcel. I also observed two layers of filter socks placed around the southern perimeter of the fishpond (Photograph 18). Best management practices are considered part of the construction support activities and must be included in the area calculation for NPDES coverage for storm water runoff associated with construction activities.

**Photograph 18:** View, facing northwest, of the southern end of the fishpond (yellow arrow). Note the double layer of filter socks placed around the fishpond (red arrow). Photograph taken by Bobbie Teixeira on November 27, 2023.

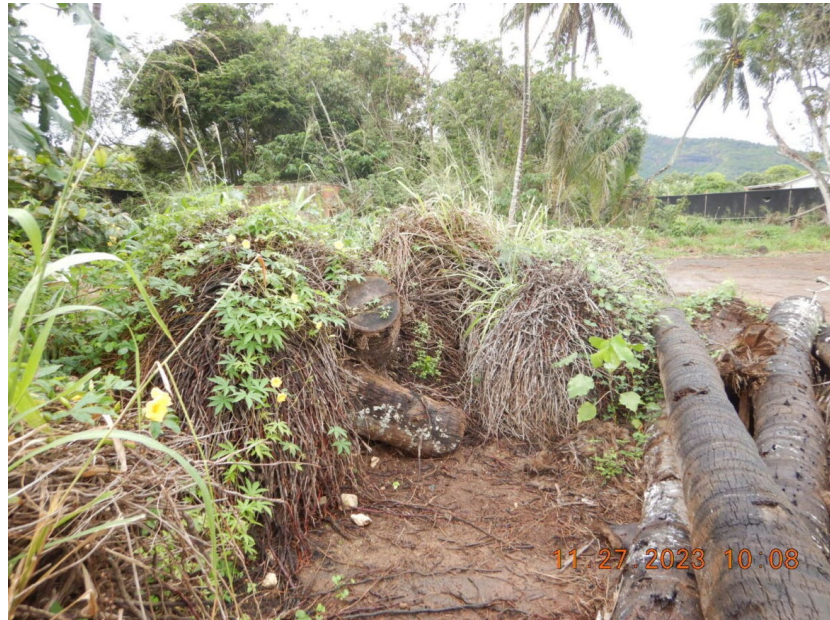
**Photograph 19:** View, facing west, of coconut tree roots and stumps stored on the northern end of Parcel 7. Photograph taken by Rande Tubal on November 27, 2023.

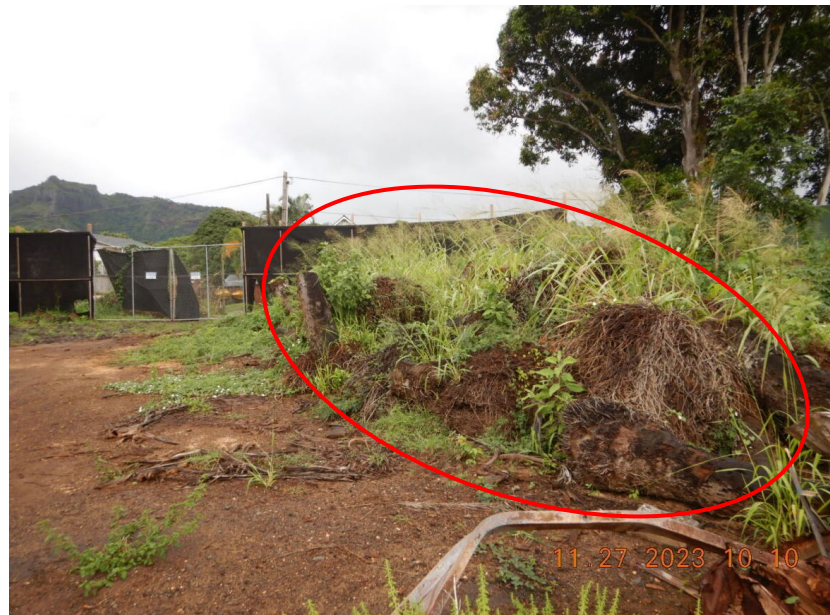
**Photograph 20:** View, facing north, of more coconut tree roots (stored on the northern end of Parcel 7). Note the Apana Street construction entrance in the background. Photograph taken by Rande Tubal on November 27, 2023.

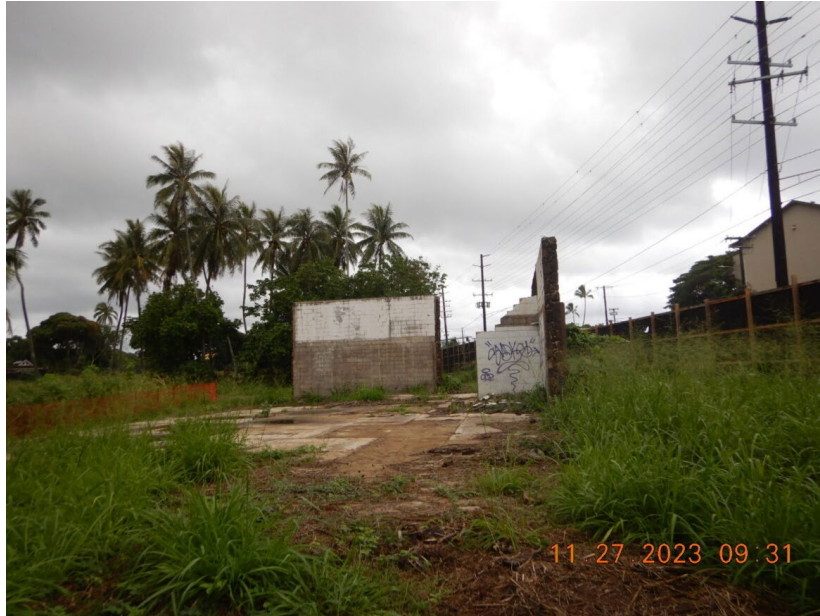
- f. *Potential Violation:* Site representatives escorted us to a structure near Kuhio Hwy that consisted of two (2) free standing walls and a concrete foundation. The site representatives informed us of their plan to demolish the two (2) free standing walls that week. CWB inspectors informed the site representatives that demolition may be considered as construction activity requiring an NPDES permit, as it is a part of a total common plan of development for the project (Photograph 21).

**Photograph 21:** View of the walls on Parcel 7, slated for demolition. Photograph taken by Randee Tubal on November 27, 2023.
