**Subject: National Pollutant Discharge Elimination System (NPDES)  
Notice of General Permit Coverage (NGPC)  
Coco Palms Resort  
4-241 Kuhio Highway  
Kapaa, Island of Kauai, Hawaii  
File No. HIR10H353**

**Hawaii Department of Health  
Clean Water Branch  
National Pollutant Discharge Elimination System (NPDES)  
Construction Storm Water Inspection Report**

**Site Name:** Coco Palms Resort

**Inspection Report Number:** PA2142

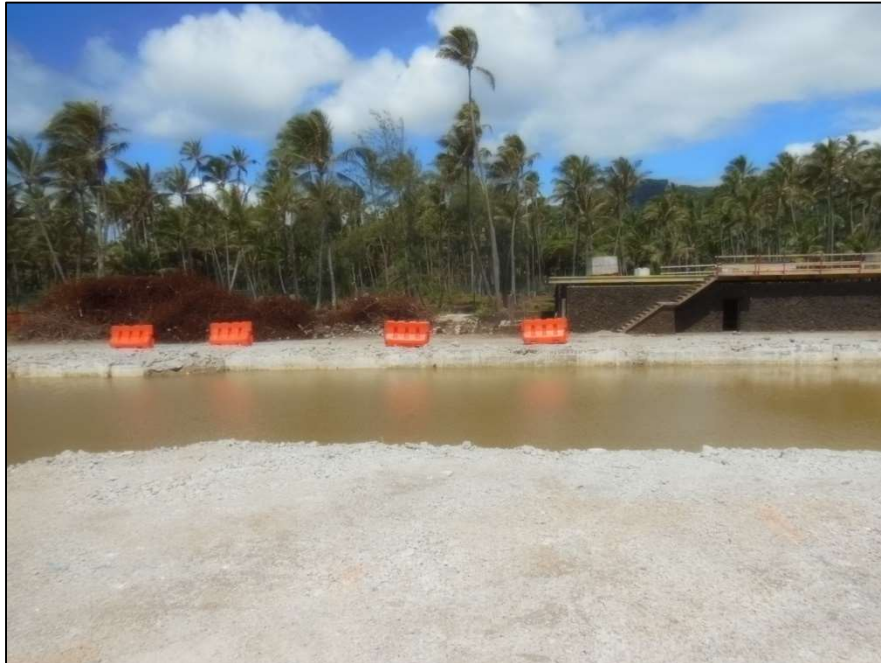
**Photograph 7.**

- c. *Observation:* I observed turbid brown water located in the parking garage of the demolished building (refer to [Photograph 7](#)). When asked how the turbid water was going to be disposed, Mr. Trask stated via email (received on 4/24/24) that the water was going to be disposed via land application and infiltration.

Description: View, facing west, of the turbid water in the parking garage of the demolished building located on the southeastern side of the site.

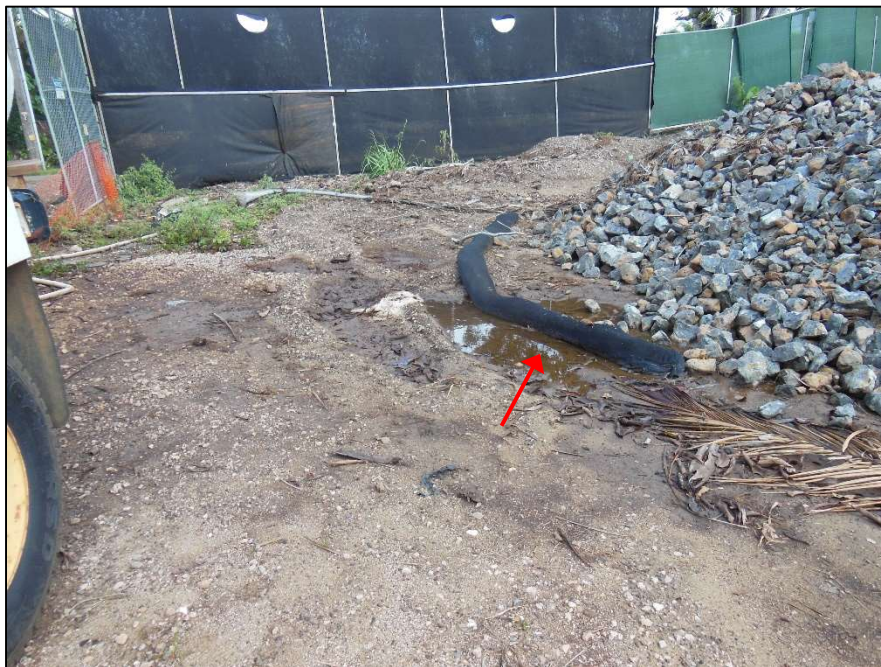
**Photograph 8.**

1. Section 5.1.2.2.1 of HAR 11-55, Appendix C requires the Permittee to “install sediment controls along those perimeter areas of the site that will receive storm water from earth-disturbing activities.”
  - a. *Potential Violation:* I observed that perimeter controls were not in place along sections of the northwestern perimeter (refer to [Photographs 8 through 12](#)), sections of the southern perimeter (refer to [Photograph 13](#)) and sections of the southwestern perimeter (refer to [Photographs 14 through 16](#)) of the earth disturbing areas of the Site. The SWPPP identified perimeter controls were installed in these locations. Mr. Amshoff stated that the straw wattles were installed but had been displaced during the storm event four days prior. On the Site walk, I observed displaced straw wattles throughout the Site.

Description: View, facing northwest, of the northwest perimeter of the Site near the Site entrance. Note the displaced straw wattle (red arrow).

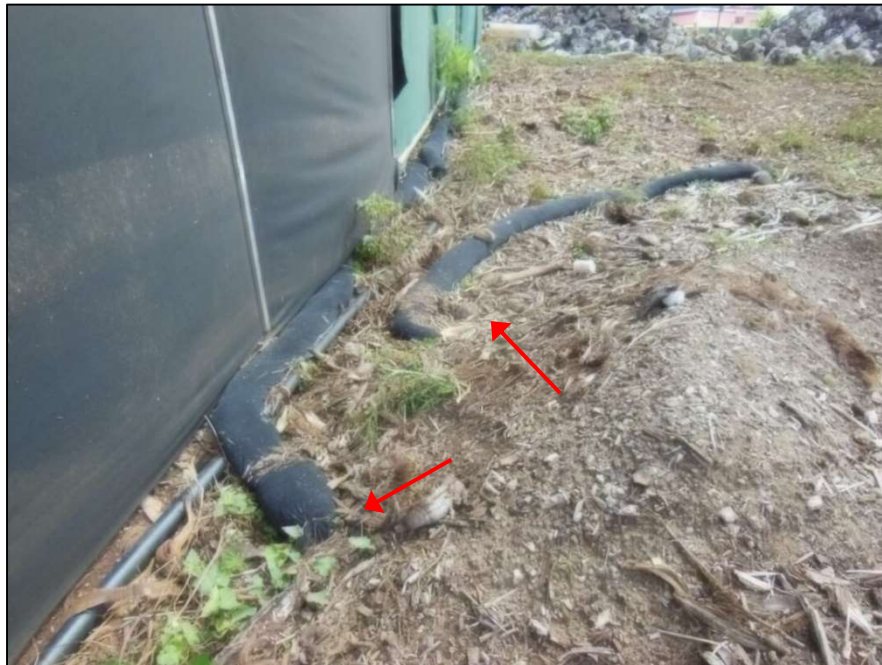
**Photograph 9.**

Description: View, facing northwest, of the northwest perimeter of the Site near the rock storage piles. Note the displaced straw wattles (red arrows).

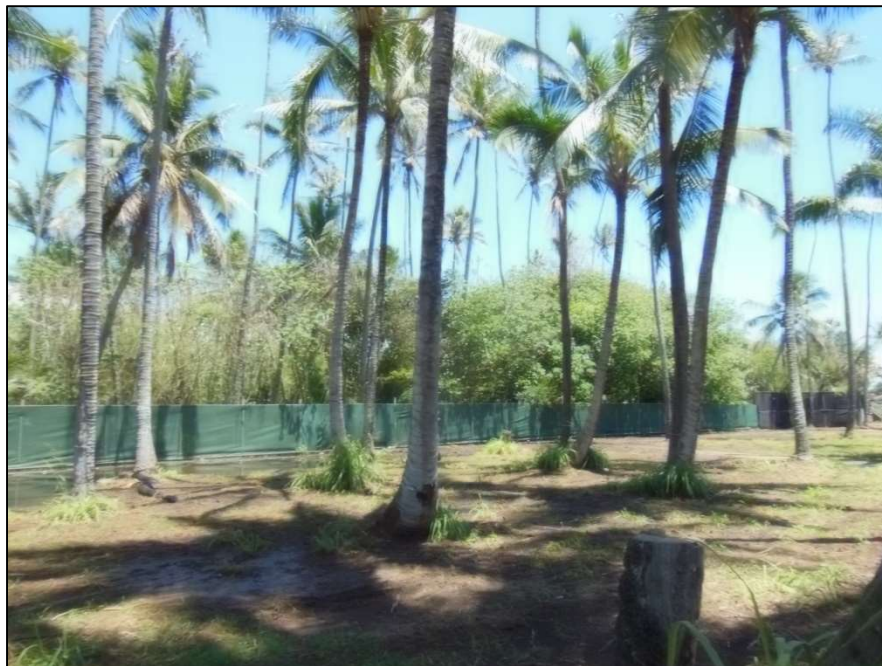
**Photograph 10.**

Description: View, facing northwest, of the northwest perimeter of the Site. Note that perimeter straw wattles were not installed along the perimeter.

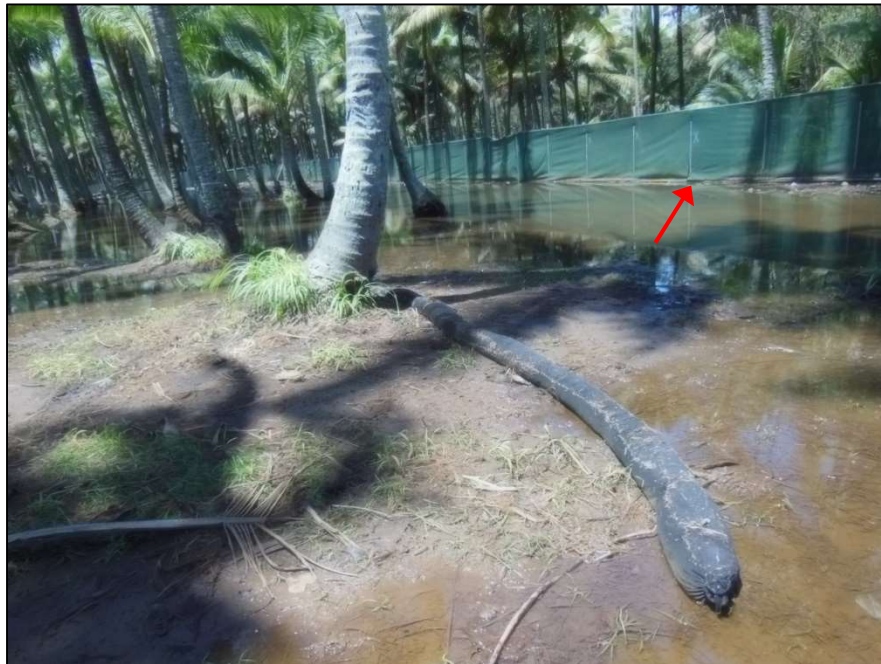
**Photograph 11.**

Description: View, facing southwest, of the northwest perimeter of the Site. Perimeter straw wattles were not installed along the perimeter (red arrow). The Site representatives stated that the straw wattles in this Photo were displaced from the northwest perimeter during the storm event.

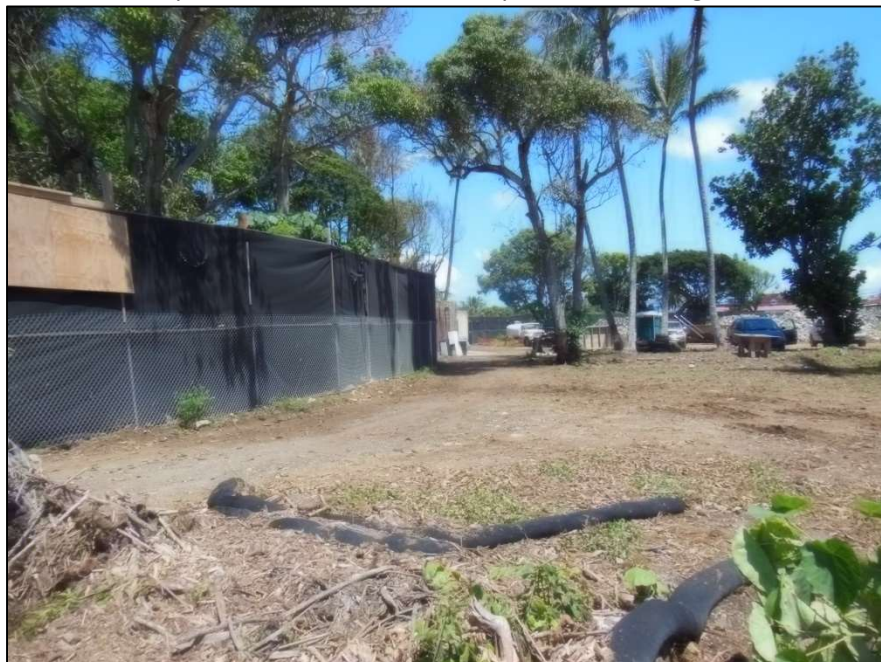
**Photograph 12.**

Description: View, facing north, of the northwest perimeter of the Site where the perimeter straw wattles had been displaced by the storm event.

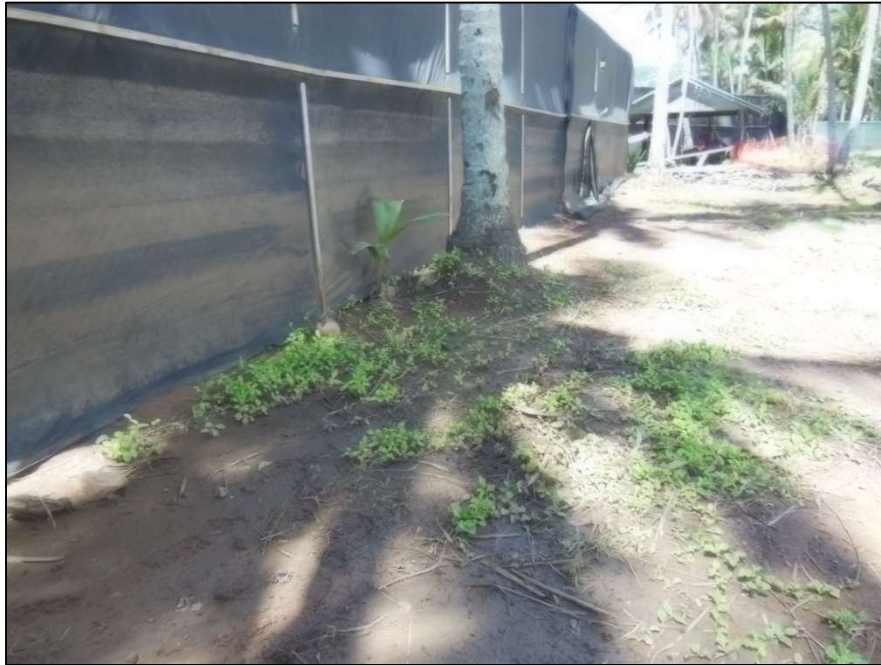
**Photograph 13.**

Description: View, facing west, of the southern perimeter of the Site. Perimeter controls were not observed installed along this section of the perimeter.

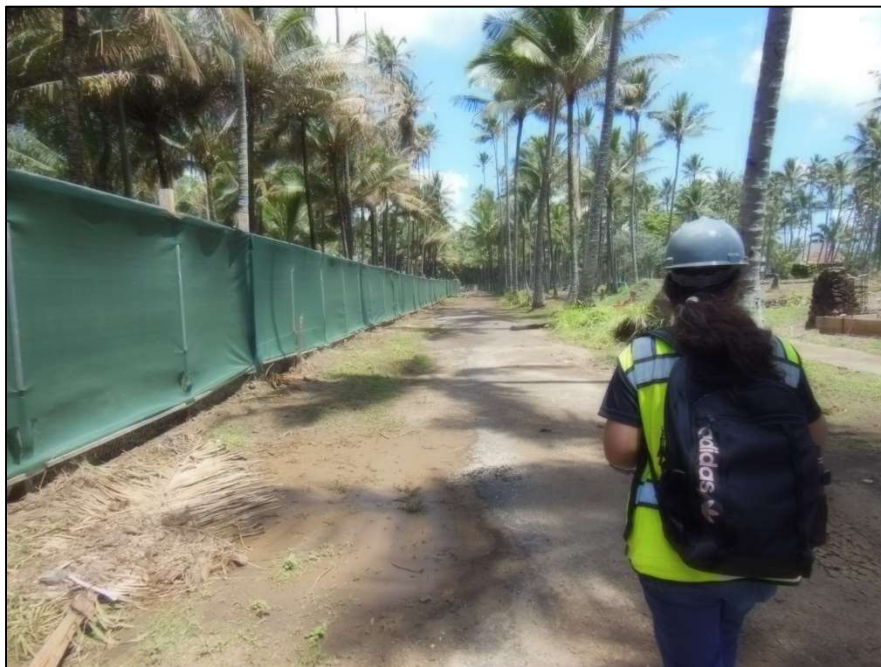
**Photograph 14.**

Description: View, facing northwest, of the southwestern perimeter of the Site. Perimeter controls were not observed installed along this section of the perimeter.

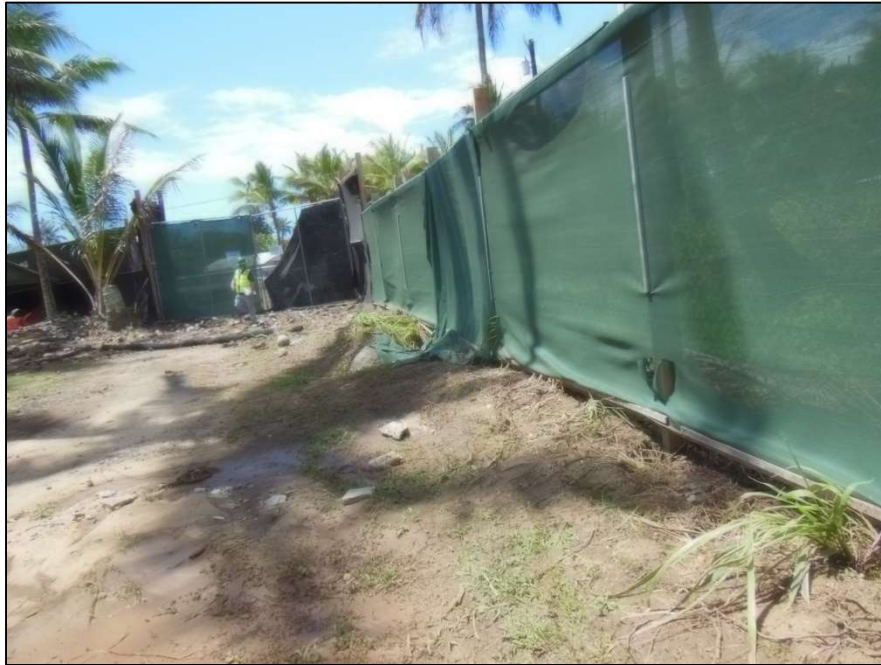
**Photograph 15.**

Description: View, facing southeast, of the southwestern perimeter of the Site. Perimeter controls were not observed installed along this section of the perimeter.

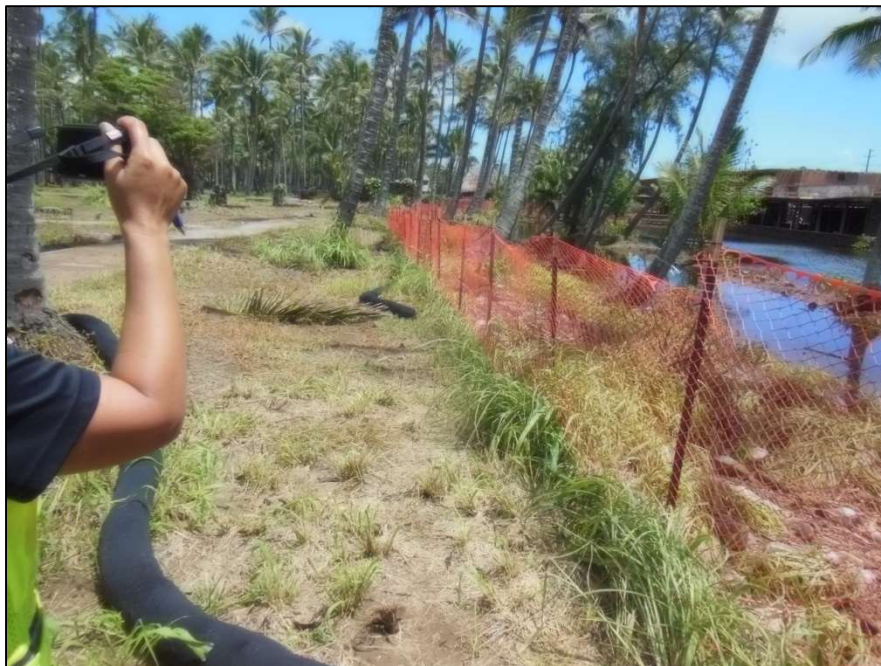
**Photograph 16.**

Description: View, facing north, of the southwestern side of the Coco Palms Lagoon. The Site representatives stated that the straw wattles shown were displaced by the storm event.

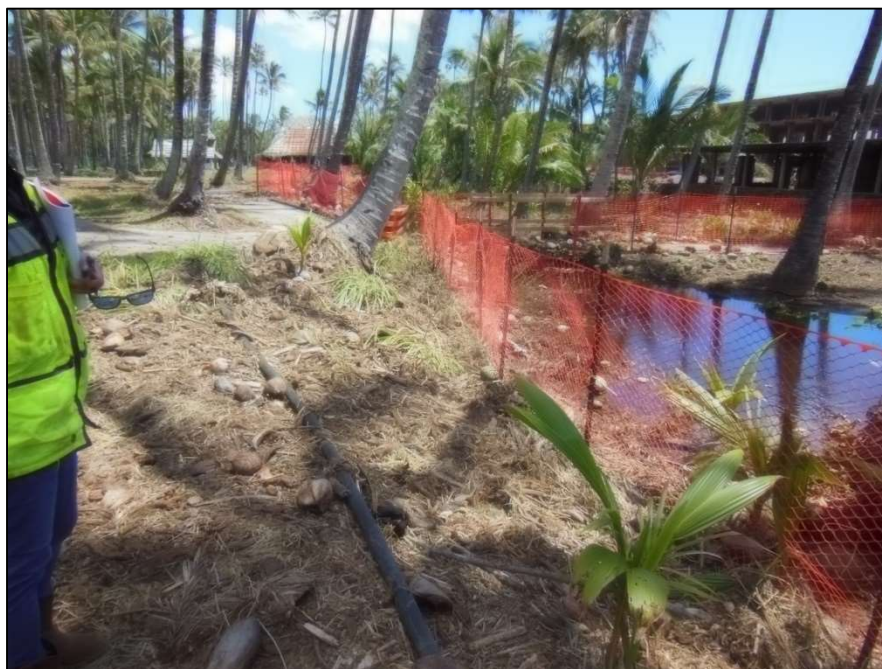
**Photograph 18.**

Description: View, facing north, of the State Ditch on the located on the western side of the Coco palms Lagoon. Sediment controls were not observed along the boundary of the State Ditch.

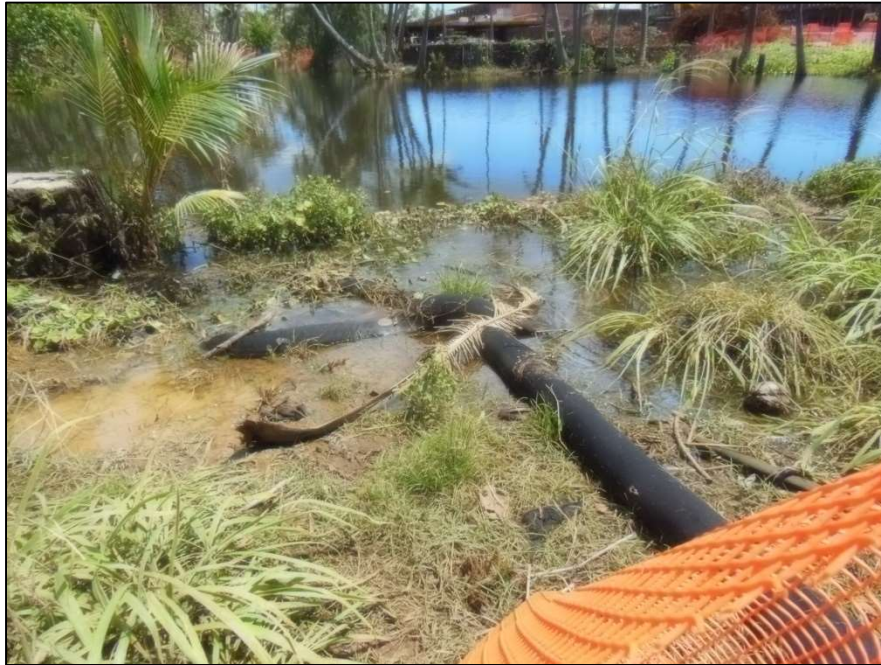
**Photograph 19.**

Description: View, facing north, of the southern edge of the Coco Palms Lagoon. The Site representatives stated that the displaced straw wattle had been installed around the Coco Palms Lagoon prior to the storm event.

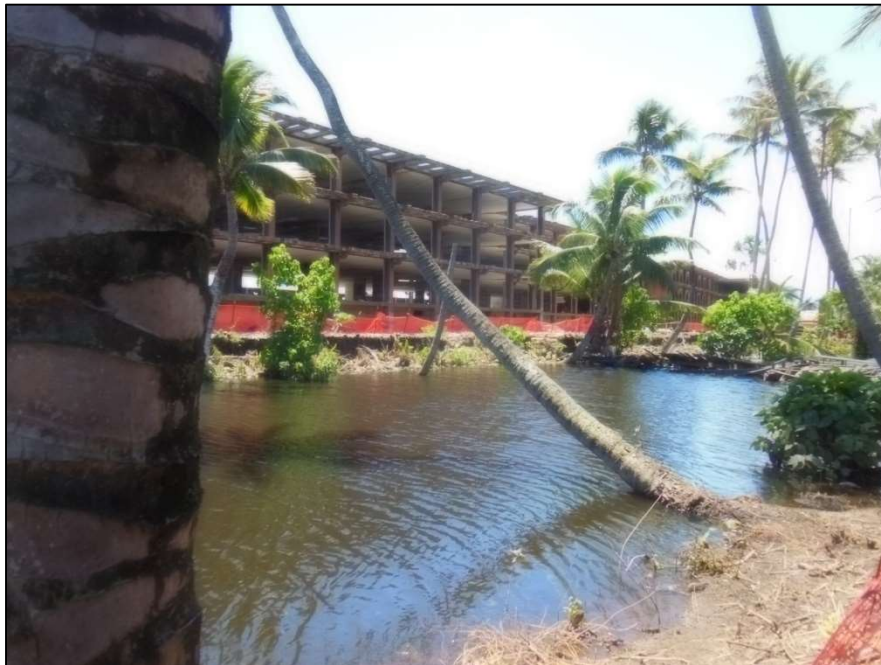
**Photograph 20.**

Description: View, facing southeast, of the northern part of the Coco Palms Lagoon. Perimeter controls were not observed around this section of the Coco Palms Lagoon perimeter.

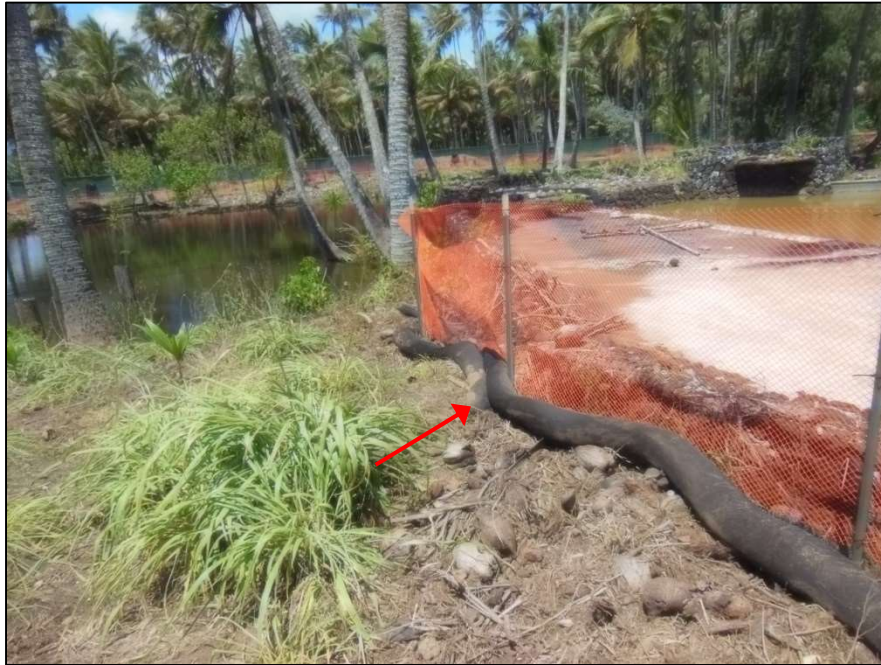
**Photograph 21.**

- a. *Potential Violation:* The compliance option for complying with Section 5.1.2.1 of HAR 11-55 Appendix C that was selected in Section 3.2 of the Site's SWPPP was as follows: "It is infeasible to provide and maintain an undisturbed natural buffer of any size, the permittee shall provide and maintain double sediment control (e.g., perimeter control) spaced a minimum of 5 feet apart and complete stabilization within 7 calendar days of the temporary or permanent cessation of earth-disturbing activities."

Description: View, facing west, of the southern part of the Coco Palms Lagoon. Note that a single straw wattle is installed along the Coco Palms Lagoon perimeter.

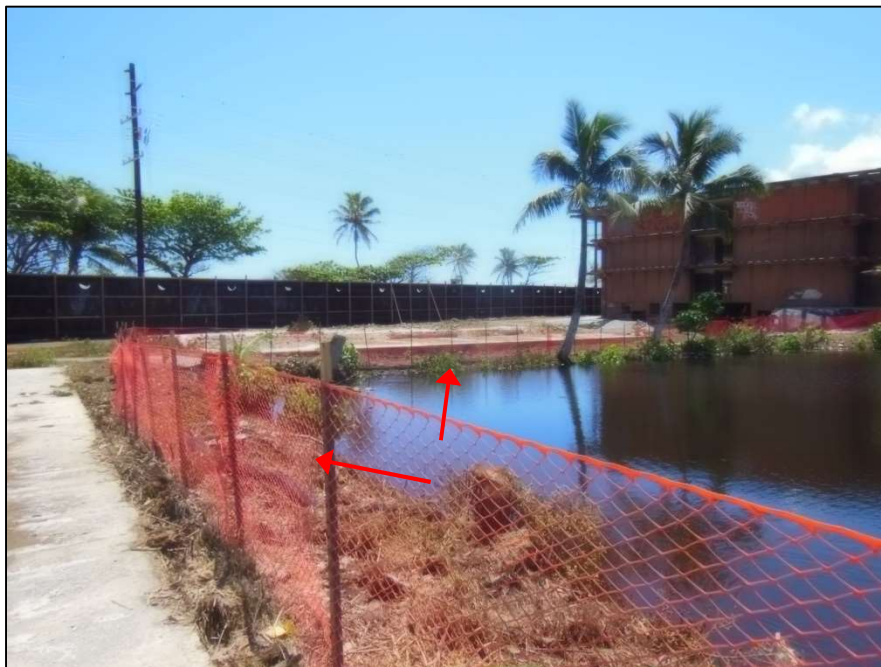
**Photograph 22.**

Description: View, facing southeast, of the northern part of the Coco Palms Lagoon. A single straw wattle was observed along this section of the Coco Palms Lagoon (red arrows).

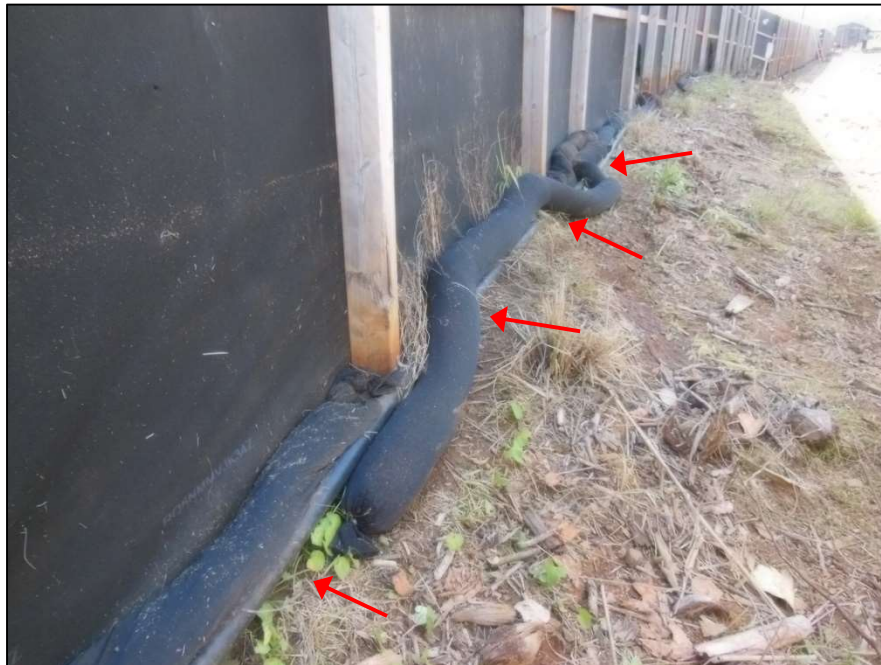
**Photograph 23.**

Description: View, facing south, of the eastern perimeter on the north side of the Site. The perimeter straw wattle was observed positioned above the water supply hose at several points along the perimeter (red arrows).

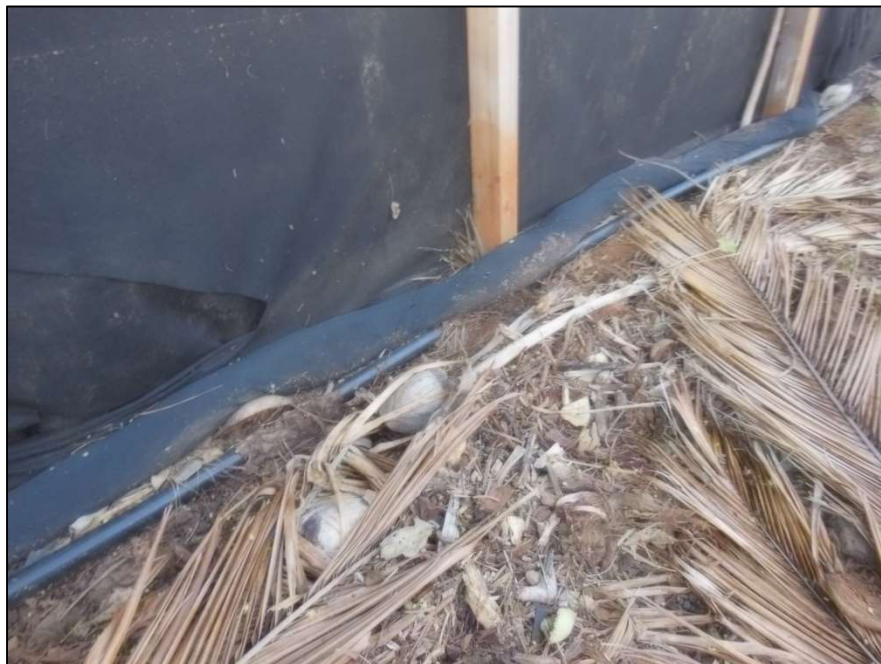
**Photograph 24.**

Description: Additional view of the straw wattle along the eastern perimeter positioned above the water supply pipeline.

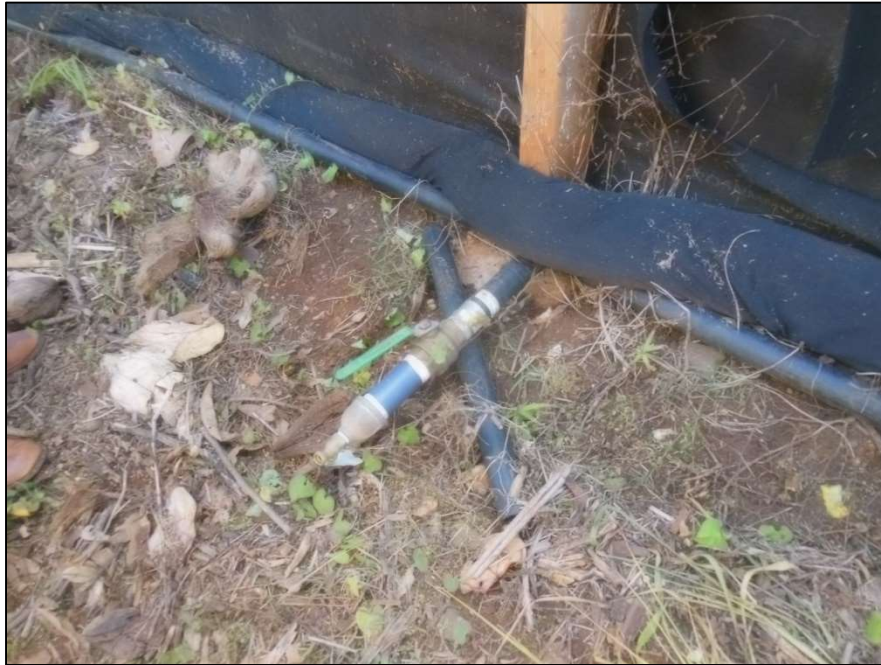
**Photograph 25.**

Description: View of a second section of straw wattle along the eastern perimeter positioned above the water supply pipeline.

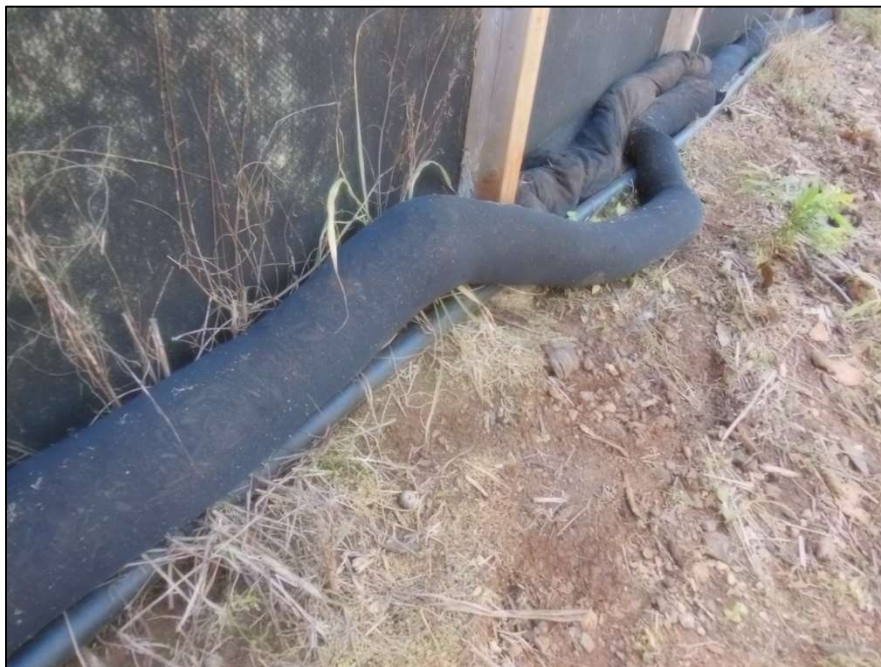
**Photograph 26.**

Description: View of a third section of straw wattle along the eastern perimeter positioned above the water supply pipeline.

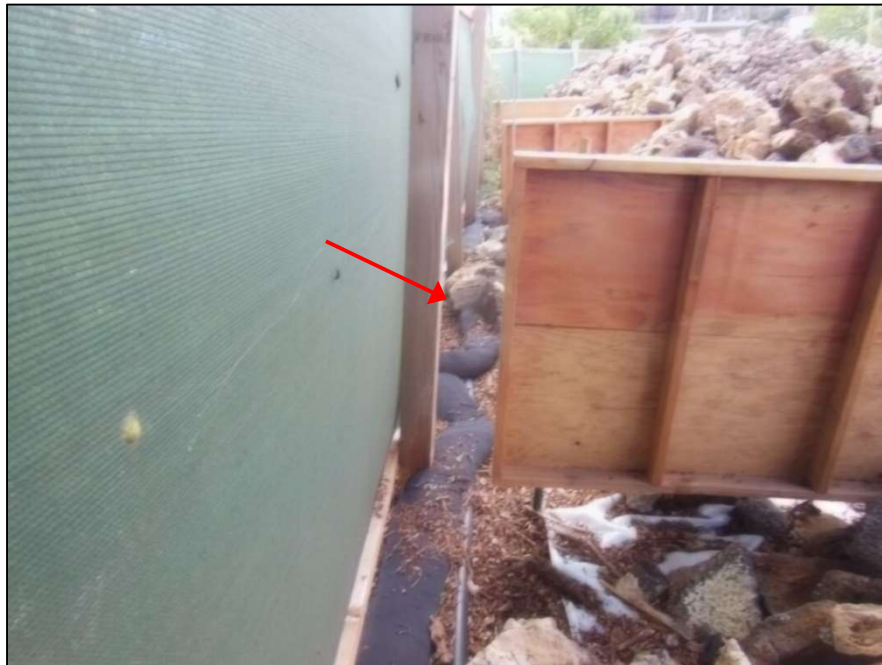
**Photograph 27.**

Description: View, facing west, of the northern perimeter of the Site. Note the rock stockpile overtopping the straw wattle (red arrow).

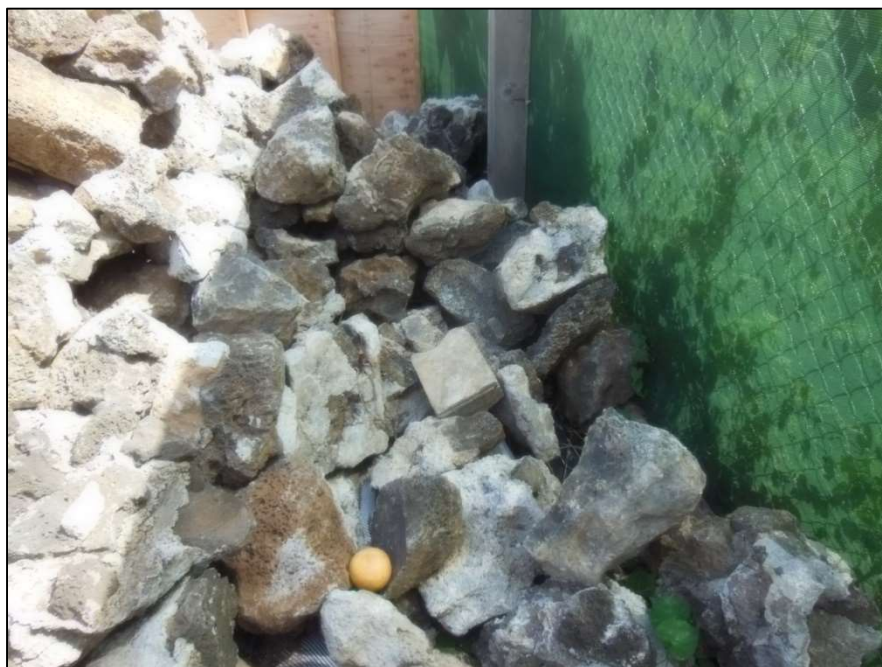
**Photograph 28.**

Description: Closer view of the rocks on top of the straw wattle shown in [Photograph 26](#).

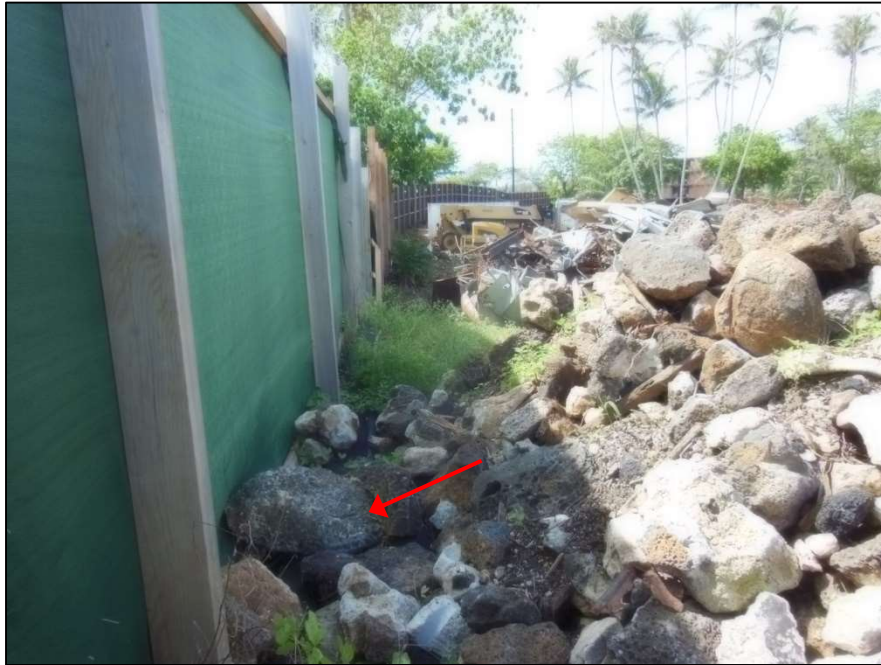
**Photograph 29.**

Description: View of a second location where rocks were placed on top of the straw wattle along the northern perimeter straw wattle (red arrow).

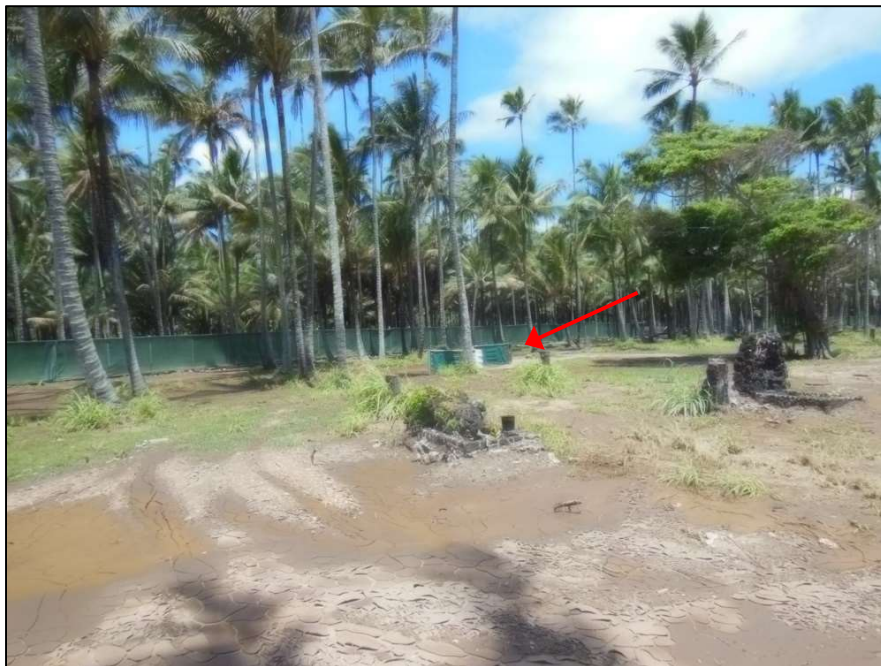
**Photograph 30.**

Description: View, facing west, of two overturned portable toilets located in the southwest portion of the Site.

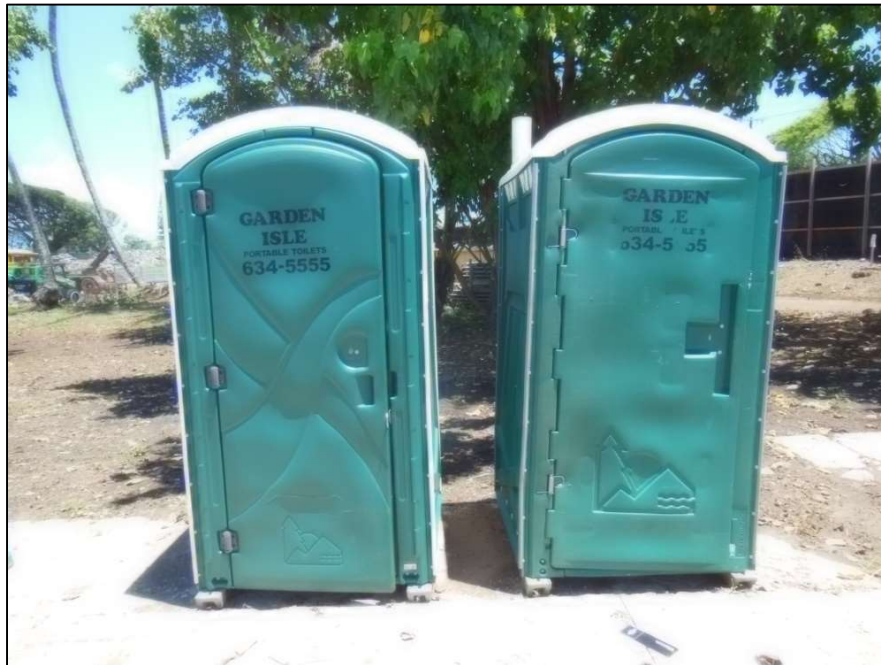
**Photograph 31.**

Description: View, facing north, of two portable toilets located north of the the northern edge of the Coco Palms Lagoon observed not staked or secured to the ground surface.

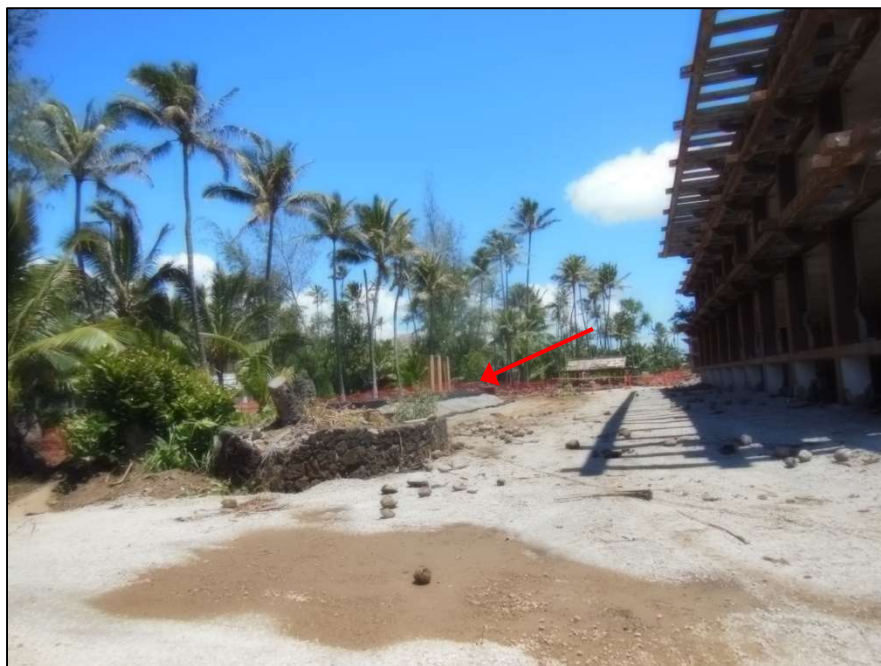
**Photograph 32.**

- b. *Deficiency:* I observed an infiltration basin installed north of the building identified in the BMP Plan (Appendix D of the SWPPP dated January 9, 2023) as “Lotus Restaurant/Flame Room Bar” and west of the building identified in the BMP plan “Alii Kai 1 Building” (refer to Photographs 32 and 33). The infiltration basin is not identified in the BMP plan.

Description: View, facing north, of the infiltration pit (red arrow) and the building identified in the BMP plan as the "Alii Kai 1 Building". The infiltration pit was not identified in the BMP plan.

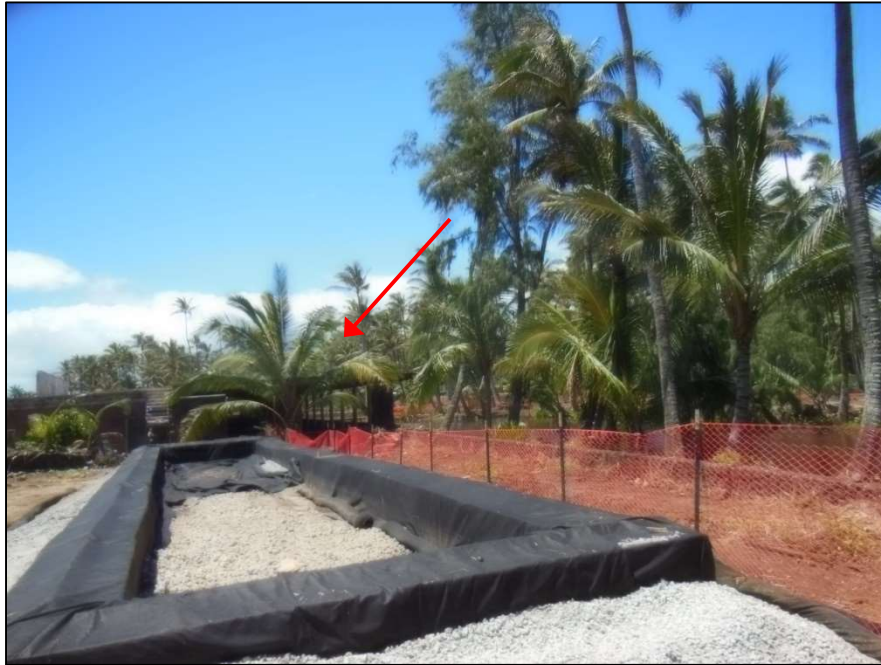
**Photograph 33.**

Description: View, facing south, of the infiltration pit and the building identified in the BMP plan as the "Lotus Restaurant/Flame Room Bar" (red arrow). The infiltration pit was not identified in the BMP plan.
