**Subject: National Pollutant Discharge Elimination System (NPDES)  
Notice of General Permit Coverage (NGPC)  
Coco Palms Resort  
4-241 Kuhio Highway  
Kapaa, Island of Kauai, Hawaii  
File No. HIR10H353**

**Hawaii Department of Health  
Clean Water Branch  
National Pollutant Discharge Elimination System (NPDES)  
Construction Storm Water Inspection Report**

**Site Name:** Coco Palms Resort

**Inspection Report Number:** PA2142

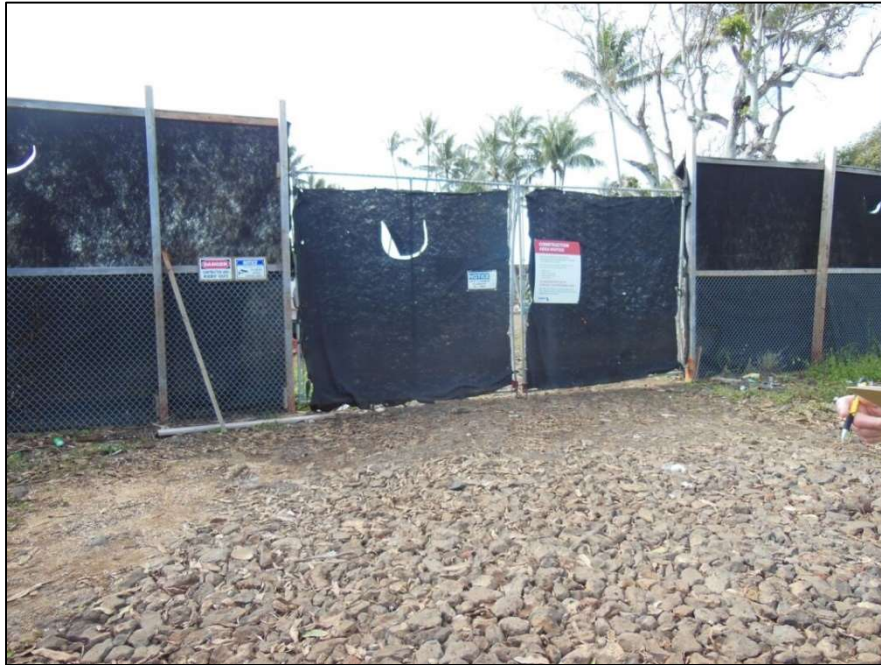
**Photograph 1.**

The Inspection Team proceeded to the Site's northeast entrance located off Apana Road (refer to [Photograph 1](#)) and were met by two Site representatives: Mr. Kent Amshoff (Project Manager) and Mr. Sean Rampton (Superintendent). Mr. Amshoff and Mr. Rampton contacted Mr. Mauna Kea Trask (an attorney with Cades Schutte LLP) who arrived approximately 10 minutes later. The Inspection Team introduced ourselves, explained the purpose of the inspection and presented a letter of authorization to perform inspections provided by the DOH. For approximately 30 minutes, Mr. Trask delayed the Inspection Team entry onto the Site, while he reviewed the Permit to verify that the Inspection Team had the right to enter and questioned whether the USEPA had jurisdiction to participate in the inspection due to recent case law regarding the definition of waters of the United States (WOTUS). Mr. Trask also verbally requested that DOH provide a copy of DOH's contract with ERG authorizing the inspection. Mr. Trask allowed the Inspection Team to enter after reviewing the Permit conditions and speaking via phone with an attorney from USEPA Region 9.

Description: View, facing southeast, of the Site entrance from Apana Street.

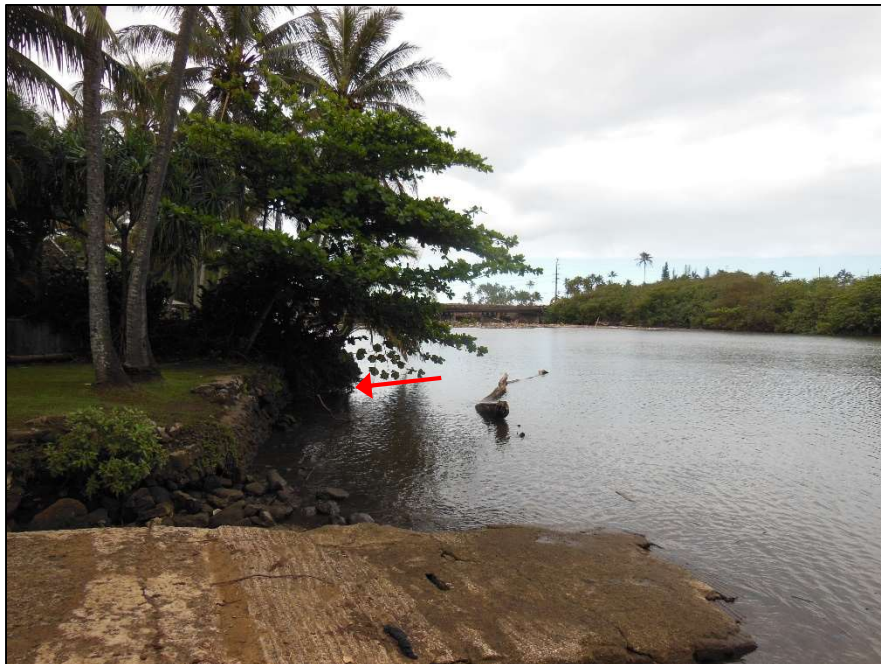
**Photograph 2.**

Prior to arriving to the Site, the Inspection Team met at Wailua State Park located south of the Site on the southern side of Kuamoo Road and observed the Wailua Coconut Grove Drainage Ditch, which runs from the southern perimeter of the Site to the Wailua River (refer to [Photographs 2 through 6](#)). Water was actively flowing through the Wailua Coconut Grove Drainage Ditch from Kuamoo Highway to the Wailua River.

Description: View, facing southeast, of the outlet from the Wailua Coconut Grove Drainage Ditch into the Wailua River (red arrow). The Wailua Coconut Grove Drainage Ditch's outlet is located on private property.

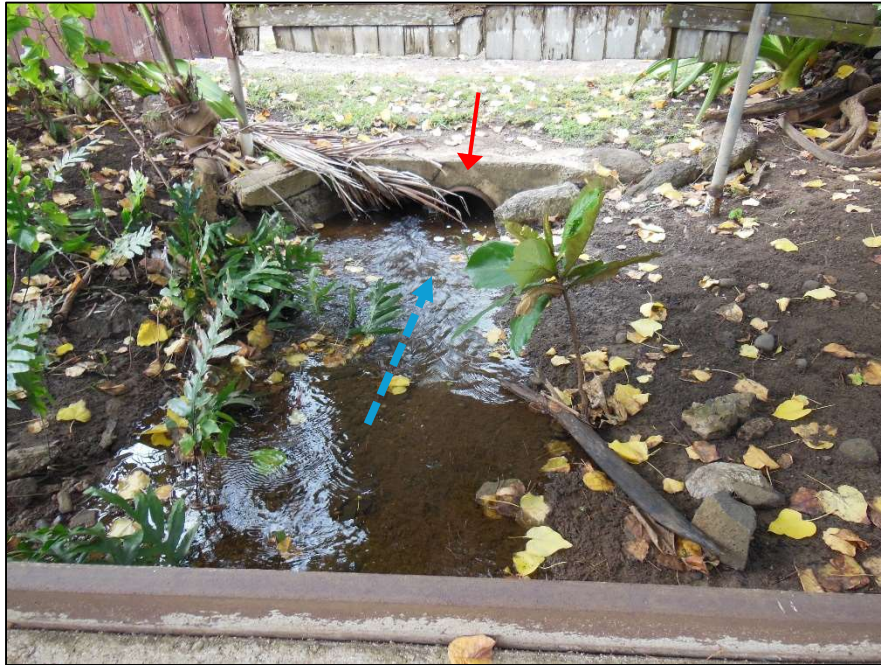
**Photograph 3.**

Description: View, facing south, of the culvert (red arrow) where the Wailua Coconut Grove Drainage Ditch enters private property. Taken from the Wailua River State Park south of the Site. Flow direction indicated by blue dashed arrow.

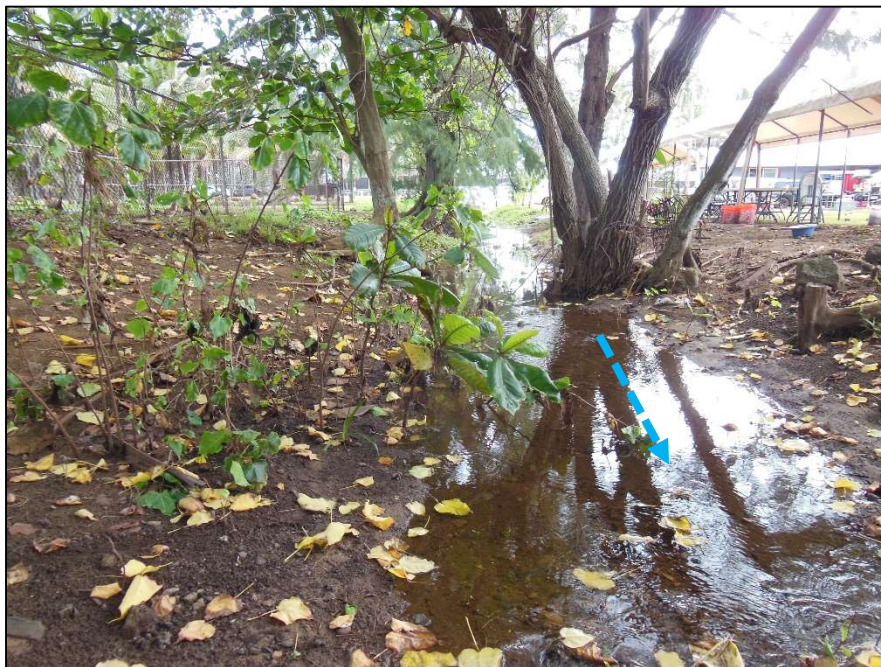
**Photograph 4.**

Description: View, facing north, of the Wailua Coconut Grove Drainage Ditch upstream of the culvert where the Wailua Coconut Grove Drainage Ditch enters private property. Taken from the Wailua River State Park south of the Site. Flow direction indicated by blue dashed arrow.

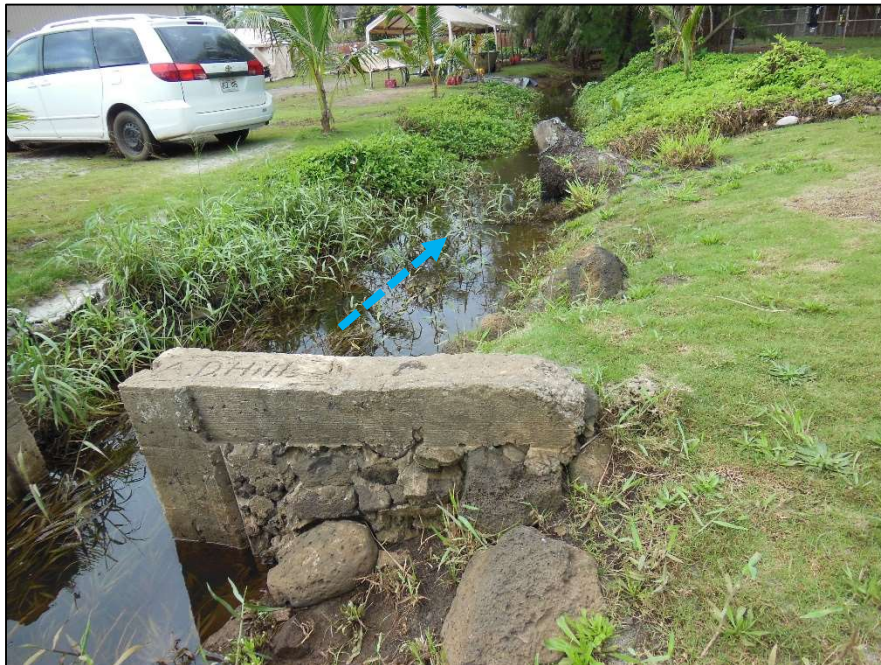
**Photograph 5.**

Description: View, facing south, of the Wailua Coconut Grove Drainage Ditch at the control gate north of where the Wailua Coconut Grove Drainage Ditch enters private property. Flow direction indicated by blue dashed arrow.

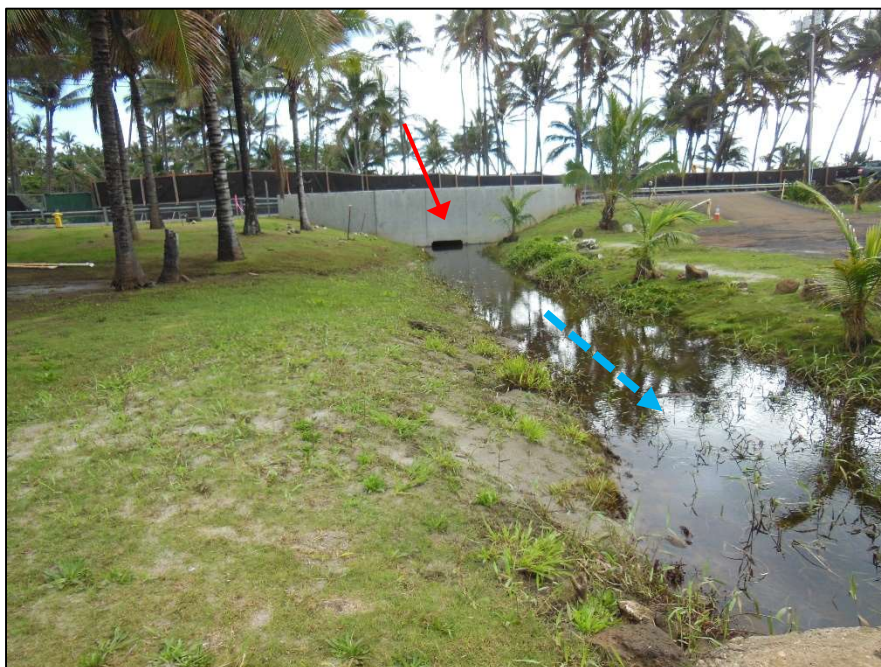
**Photograph 6.**

Description: View, facing north of the Wailua Coconut Grove Drainage Ditch running from the southern perimeter of the Site underneath Kuamoo Avenue. Photograph taken from the control gate shown in Photograph 5. Flow direction indicated by blue dashed arrow.

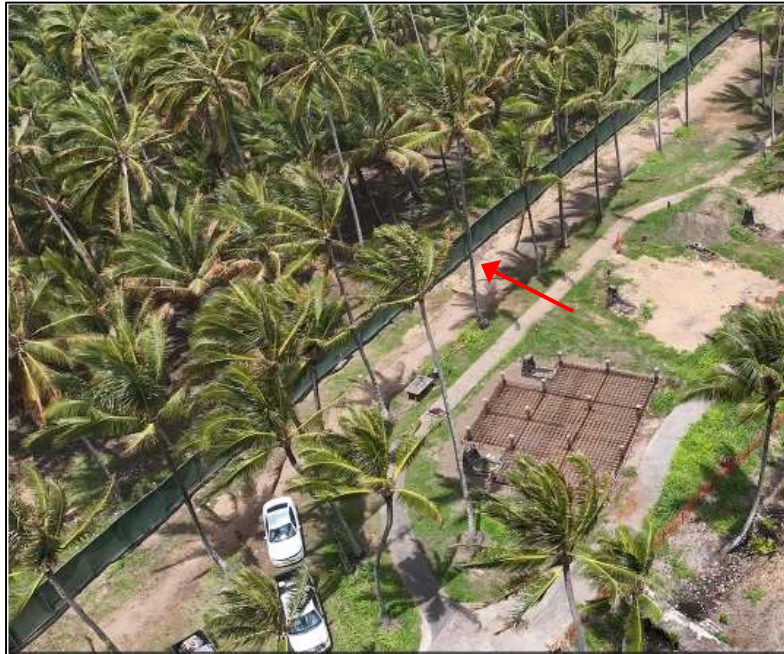
**Attachment A.**

Description: Aerial photograph of the southwest perimeter taken prior to the major storm event. Note the straw wattles installed along the perimeter (red arrow).

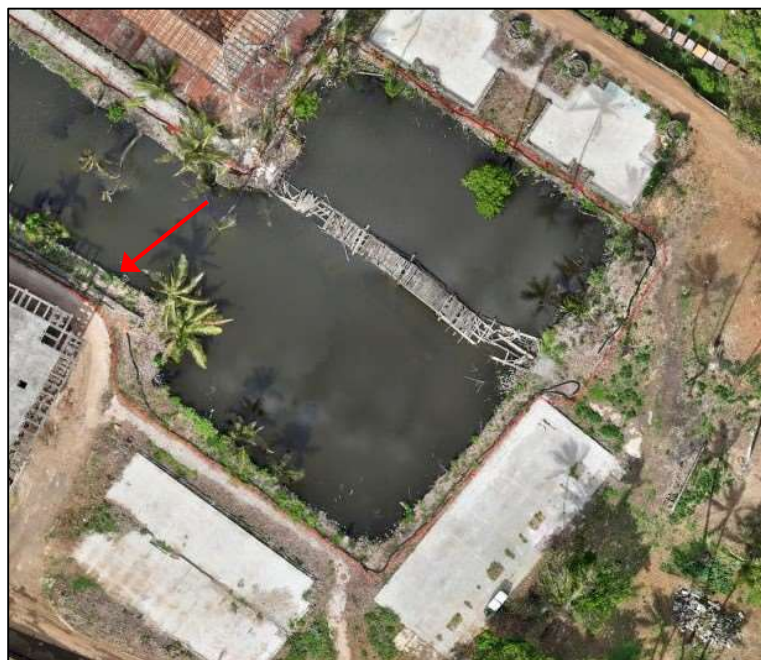
**Attachment B.**

I reviewed the Site's inspection report from April 11, 2024, and observed a single row of straw wattles installed around the Coco Palms Lagoon and the Wailua Coconut Grove Drainage Ditch (refer to [Attachments B through G](#)). I observed double straw wattles in the photographs along parts of western edge and the southern edge of the Coco Palms Lagoon (refer to [Attachments B, D, F and G](#)).

Description: Aerial photograph of the northern section of the Coco Palms Lagoon taken prior to the storm event. Note the straw wattle perimeter around the Coco Palms Lagoon, with a double straw wattle perimeter on the southeast side (red arrow).

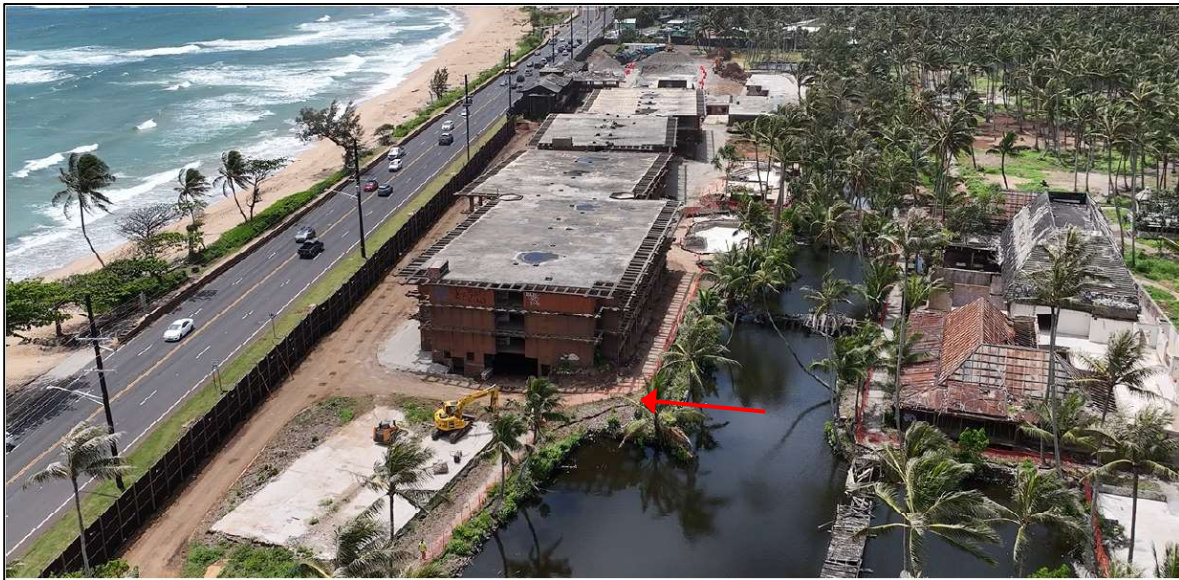
**Attachment C.**

Description: A second ariel photograph of the northern section of the Coco Palms lagoon taken prior to the storm event. Note the straw wattle along the perimeter of the western side of the Coco Palms lagoon (red arrow).

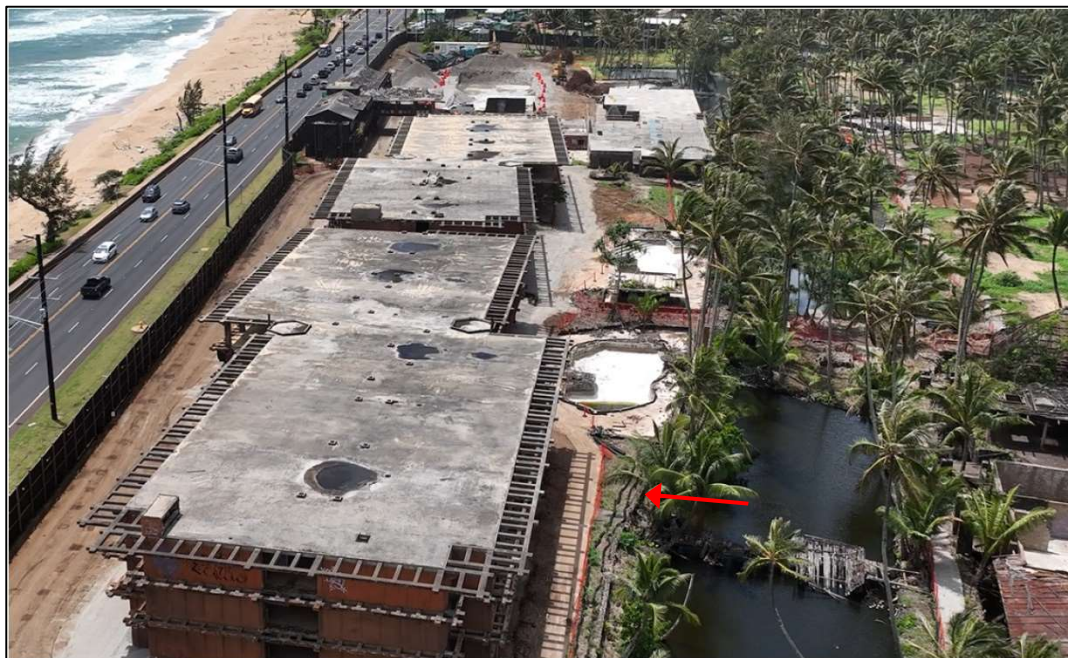
**Attachment D.**

Description: Aerial photograph of the western edge of the Coco Palms Lagoon taken prior to the storm event. Note the double straw wattle perimeter located on the southwestern side of the lagoon (red arrow).

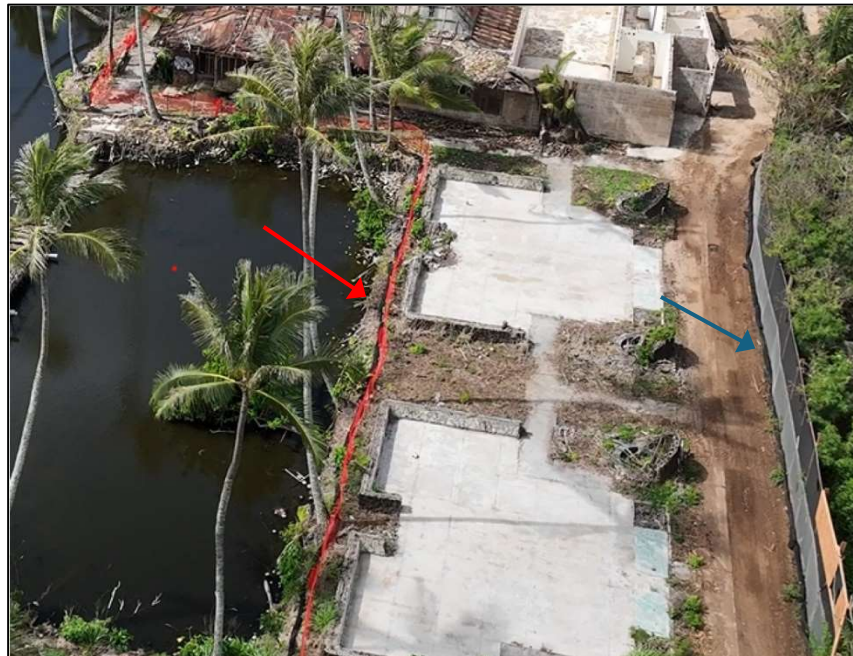
**Attachment E.**

Description: Aerial photograph of the western edge of the northern section of the Coco Palms Lagoon taken by Site personnel prior to the storm event. Note the straw wattles along the perimeter of the Coco Palms Lagoon (red arrow), and the straw wattles along the northwest sight perimeter (blue arrow).

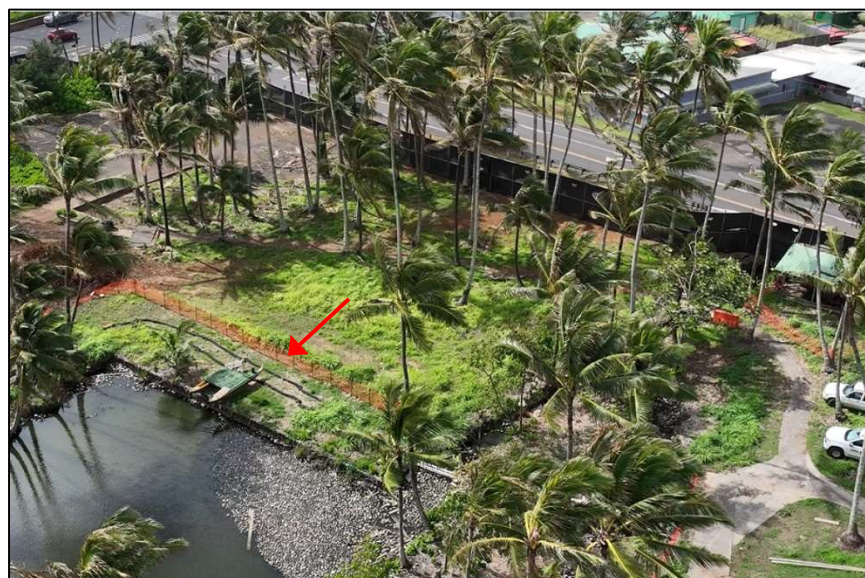
**Attachment F.**

Description: Aerial photograph of the southern edge of the lagoon taken prior to the storm event. Note the double straw wattle along the southern perimeter of the Coco Palms Lagoon (red arrow).
